**APPLICATION FOR CERTIFICATE OF APPROPRIATENESS (COA)**

Building address 520 East 4th Street, Bethlehem, PA 18015

Re: Hispanic Center  
520 East Fourth Street  
City of Bethlehem, Northampton Co., PA

**RE: HOUSE SURVEY OF EXISTING CONDITIONS  
520 E 4TH ST, BETHLEHEM, PA 18015**

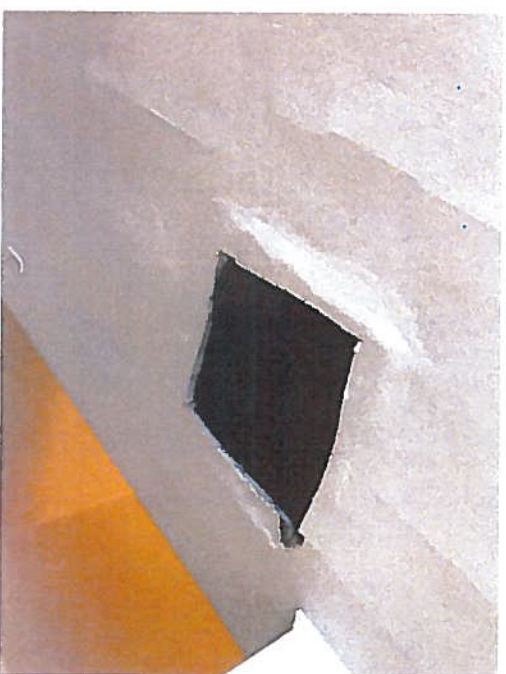
Photograph 2

When looking throughout the existing converted home, there were several concerns noted particularly the unevenness of the first floor, particularly where the house connects to the brick structure to the rear as result of settlement of the house since constructed in 1935. Also this continues throughout the house wherein method's of structural repairs were made to stabilize the wood framed structure inclusive of Simpson Strong-Ties with thread rods were previously installed at the stairway to the second floor as can be seen in Photographs 2 and 3 below.

Showing Simpson Strong-Tie installed in first floor ceiling at stairway to 2<sup>nd</sup> floor.

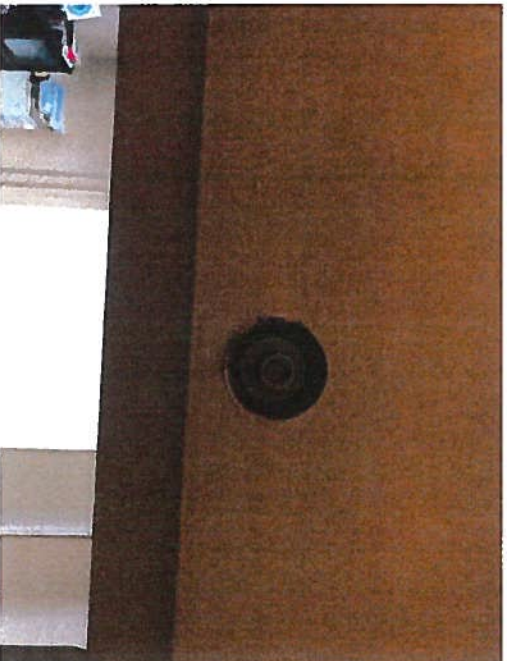
Photograph 3

Showing exposed threaded rod and nut from Simpson Strong-Tie at the stairway.

Concern noted is the longevity of the repair and likelihood that further additional repairs needing to be made as structural settlement progresses. While walking around the attic/3<sup>rd</sup> floor area the sagging of the ceiling was noted as shown in Photograph 4 below.

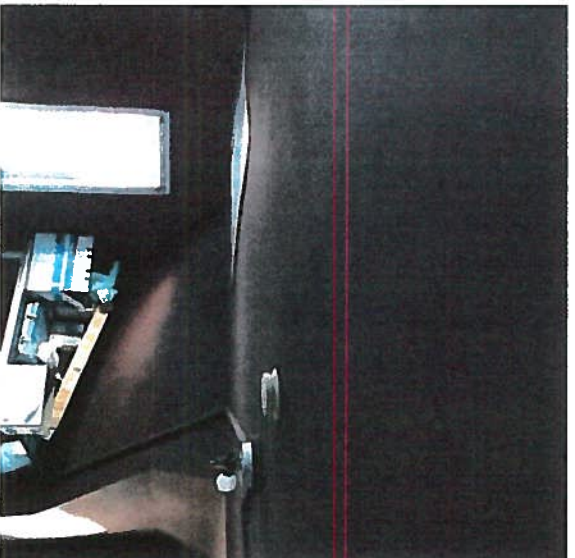
Photograph 4

Showing sagging/bulging downward of ceiling at the center of the picture and above the window at the left of the picture.

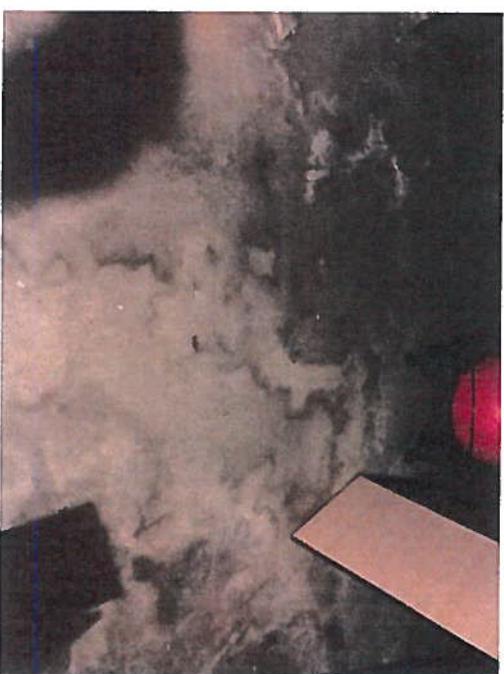
Photograph 5

Showing water staining on the concrete basement floor.

Water staining is a result of water infiltration indicative of a lack of waterproofing/damp proofing on the exterior of the basement walls. The lack of damp/waterproofing is typical with many buildings constructed during that time period.

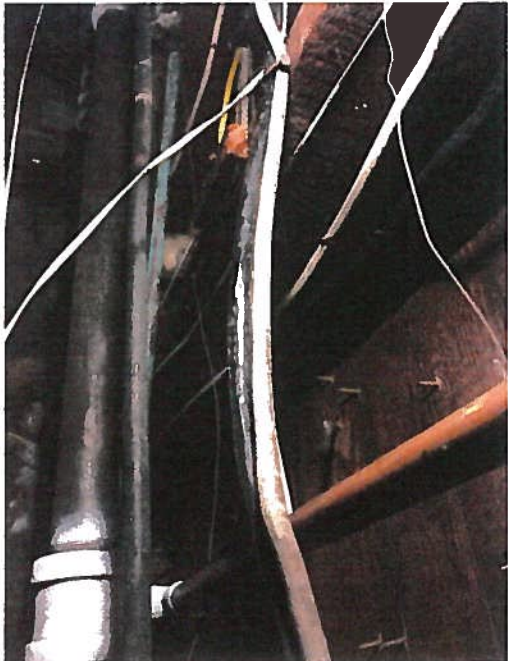
Photograph 6  
Showing extensive amount of wiring not in Metal Conduit as required by Code in office buildings

Obviously with any renovations to the facility, upgrades will be required to the wiring to conform to current building codes as well as the expenditure of up to 20% of renovation costs to make the facility ADA accessible.

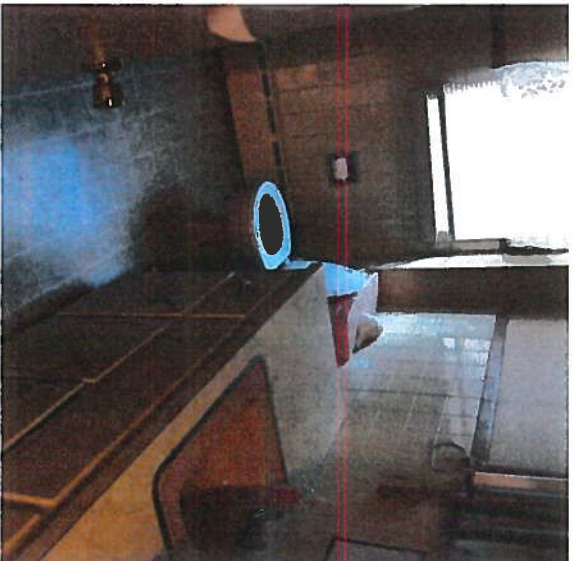
Photograph 7  
Existing restroom w/o grab bars, etc.

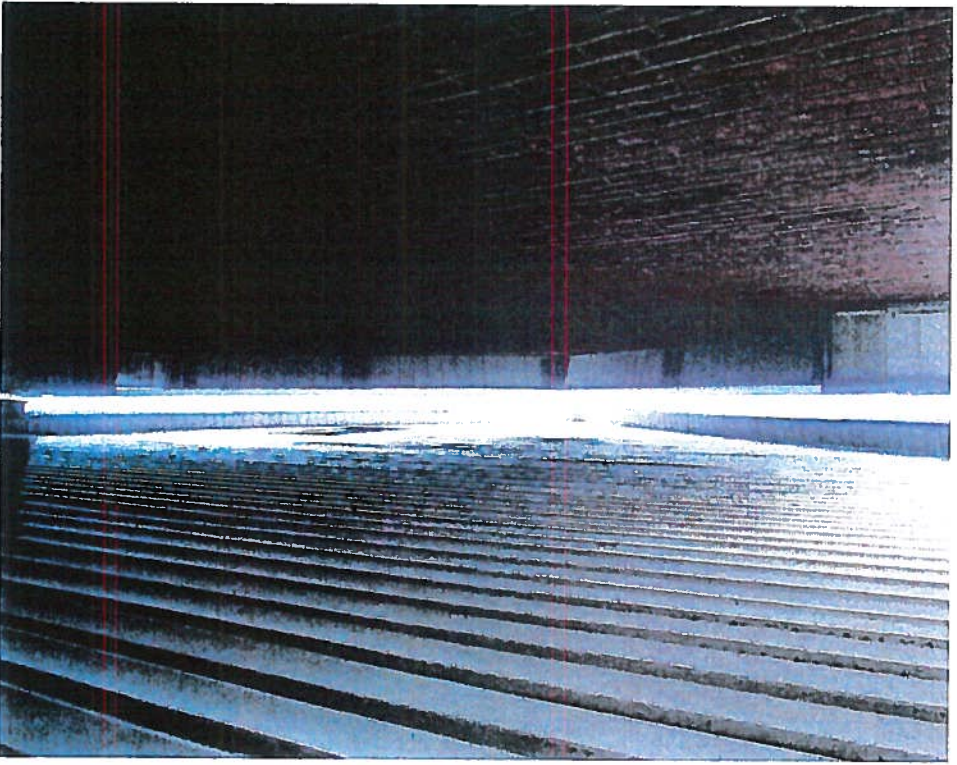
Photo 2

The observations from the exterior were limited due to the vinyl siding covering the exterior façade. We did observe that the gable end on the west side of the main roof was pushed outward toward the adjacent property (See Photo 2). This was further investigated in the attic and is discussed later in this report.

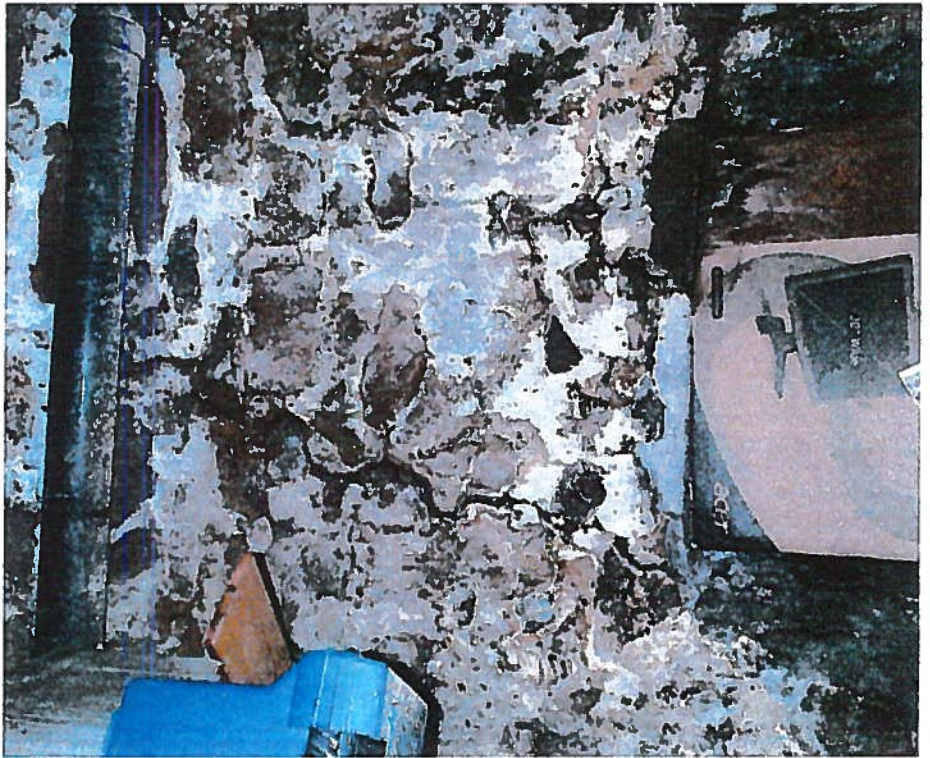
Photo 3

The basement foundation wall is constructed of rubble stone. A crack was observed at the corner of an opening in the foundation wall (See Photo 3)

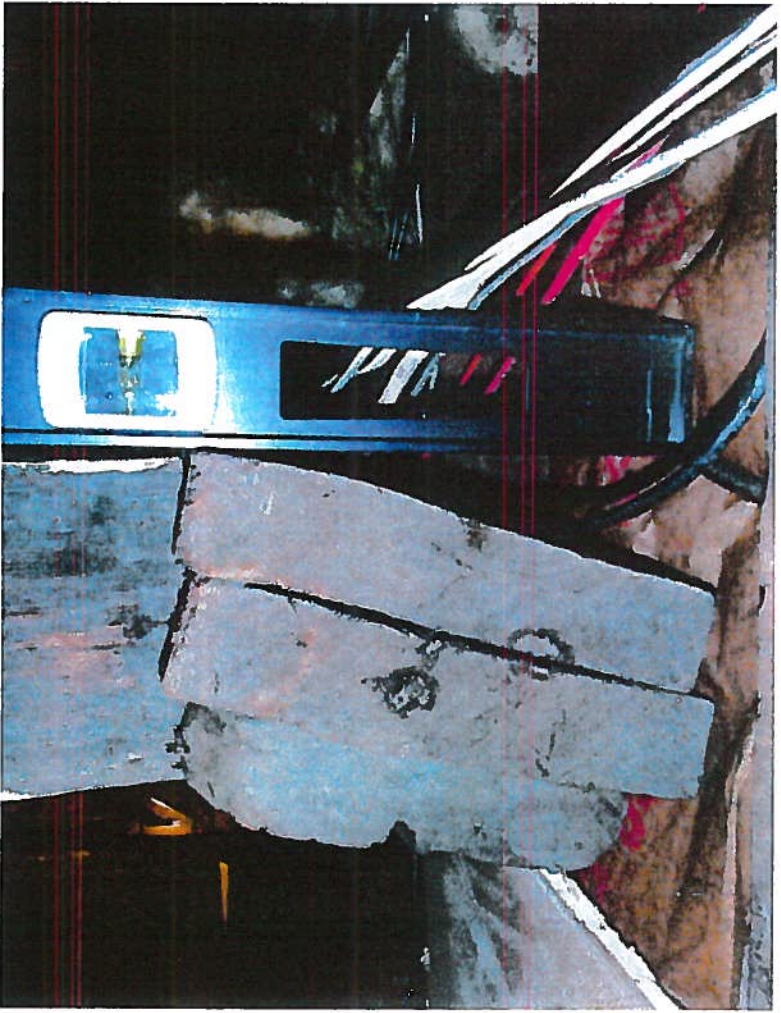
Photo 4

The first-floor framing was observed from the basement. There were 2"x 9.5" joists at approximately 18" o.c. spanning east to west. There was a beam supporting the first-floor joists at the front 27' of the basement. Where the triple 2x beam stopped it was supported by a wood post. The wood beam rotated significantly (See Photo 4). Additionally, the wood post at this location was out of plumb (See Photo 5).

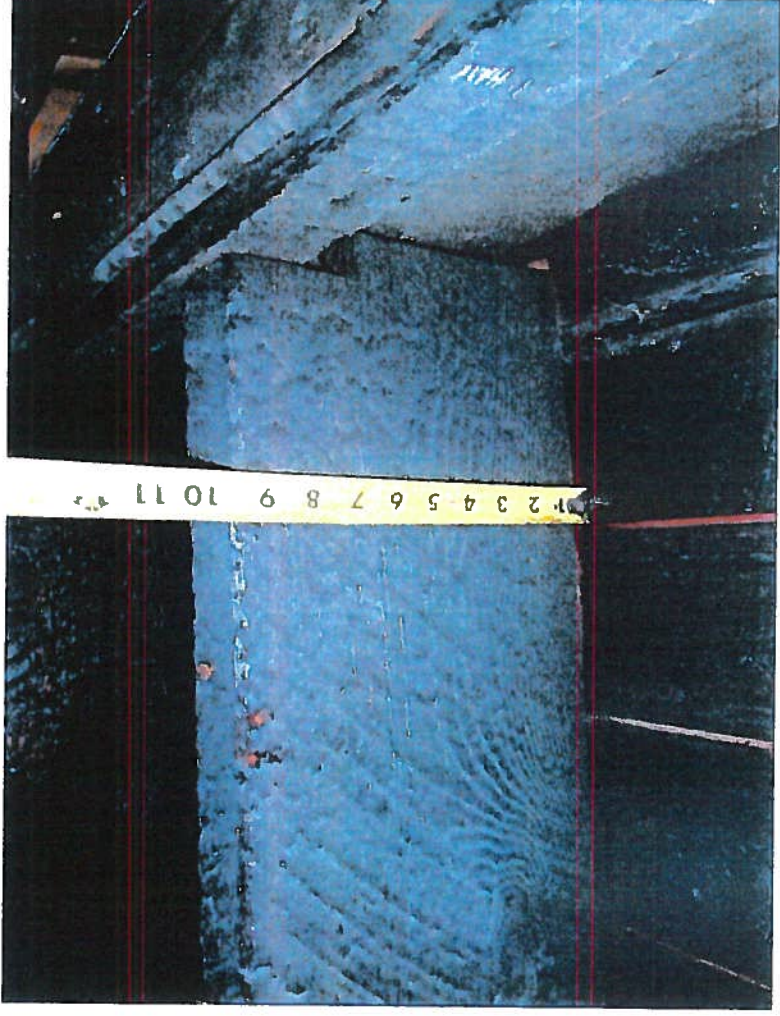
Photo 6

Adjacent to the floor opening for the stair at the first floor framing it was observed that a fire had previously occurred, and charring was present on the floor joists (See Photo 6). At one location we noted a floor joist had metal ties installed to laterally brace the floor beam at the edge of the stair opening (See Photo 7). The second floor framing adjacent to the stair opening also had two metal ties installed at the floor joist and the 2x beam framing the stair opening (See photo 8). The metal ties were installed to limit the rotation of the beam at the edge of the framing around the stairs.

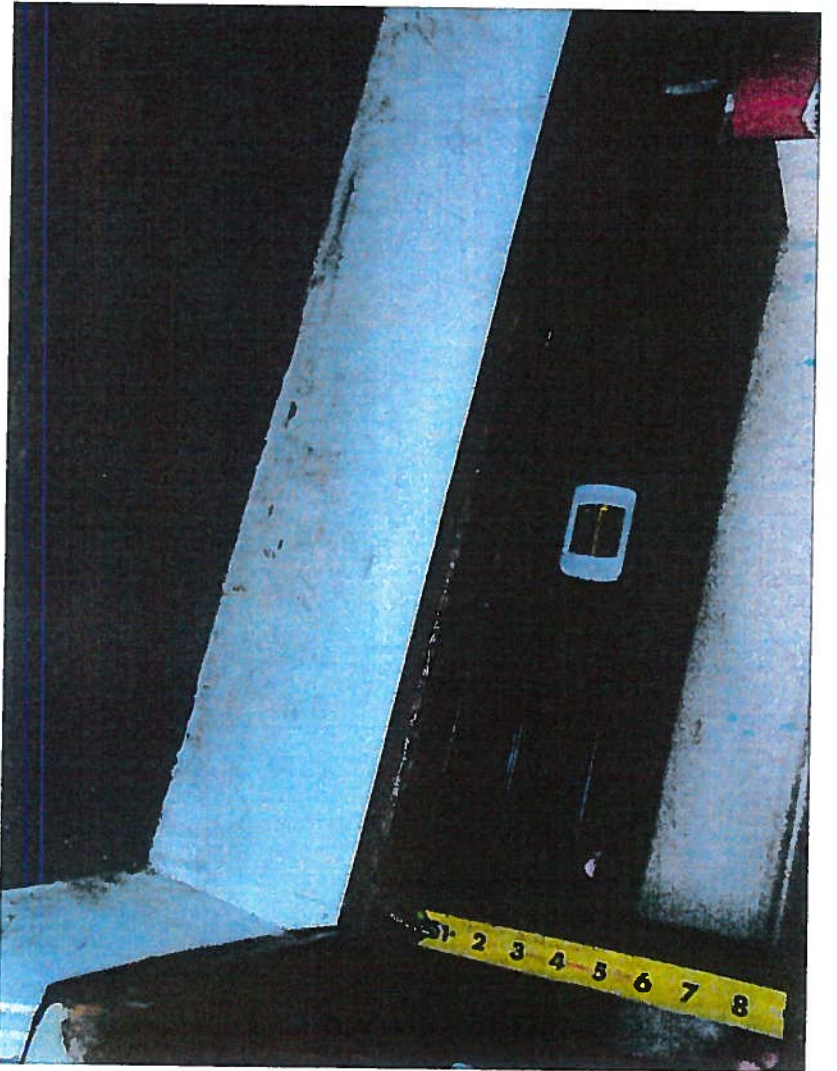
Photo 9

At the top of the stairs to the attic a level was used to determine the levelness of the floor. We measured the floor to be out of level approximately 1.75" over 4' (See Photo 9). Significant cracking was observed in the finishes in the attic and some of the cracking appeared to be recent (See Photo 10). At the ceiling of the attic space we noted irregularity of the ceiling finishes which was consistent with the settlement/movement in the structure previously noted.

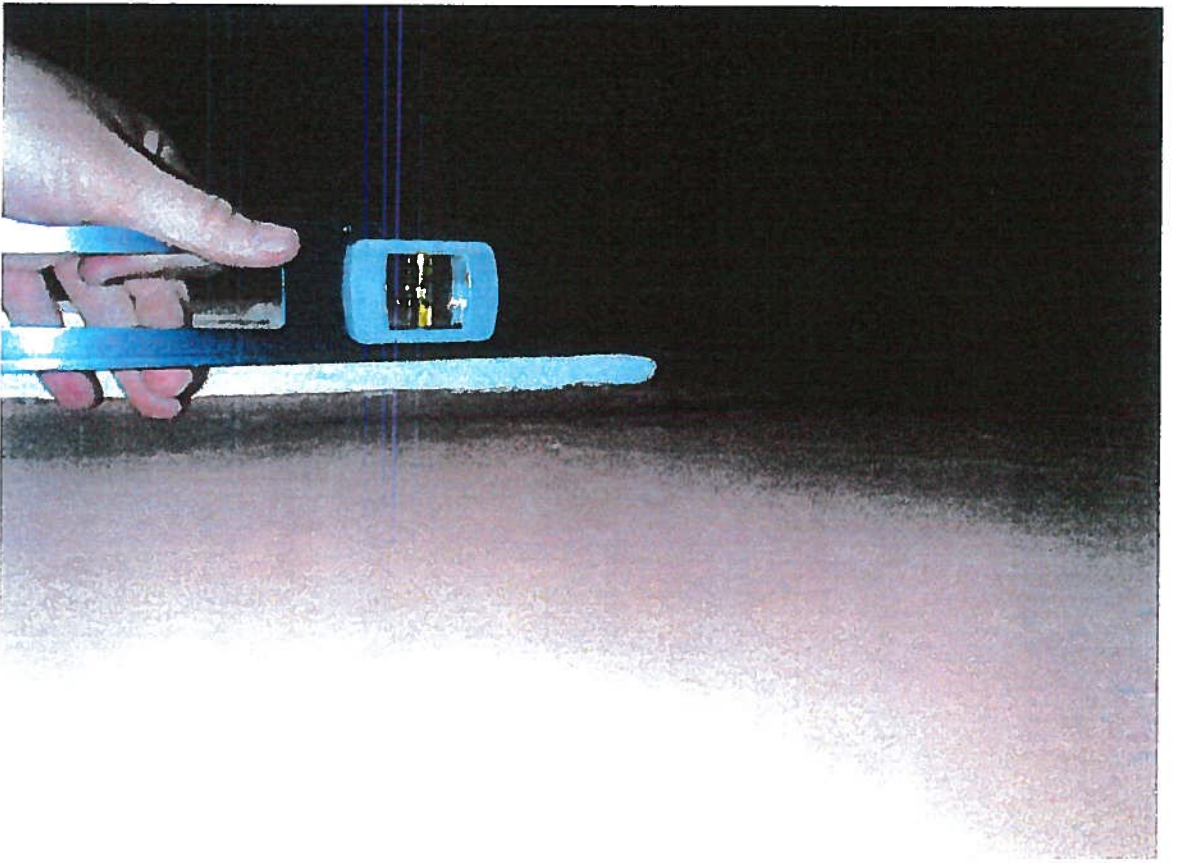
Photo 11

The west gable end wall at the attic was out of plumb approximately 1" over 4' (See Photo 11). This movement was visible from the exterior of the building as noted earlier in this report.

At the site we noted that the stair openings in the floors all stack on top of each other and are located at the west exterior wall of the structure. Movement at the framing around the stair has been an ongoing issue and has had temporary measures to mitigate the movement installed. The lateral stability of the first-floor beam and post is a significant concern. The movement noted throughout the structure above is concentrate in the area of this rotated beam and out of plumb post. The attic gable wall on the west side is not lateral braced over approximately two stories and this is likely at least partially the reason for the observed movement in the wall.

Based on our observations, there are structural deficiencies in the house structure which require repair to provide a safe building. Significant work would need to be performed to brace the walls and framing, level the floors, and address the many cosmetic and finish issues created by the structural deficiencies. The work to repair the structure would likely exceeded the value of the structure.
