APPLICATION FOR CERTIFICATE OF APPROPRIATENESS (COA)

Building address 505 E 4th St.

Windows Reinstallation & Façade Renovations

Project Description for HCC Application for Certificate of Appropriateness

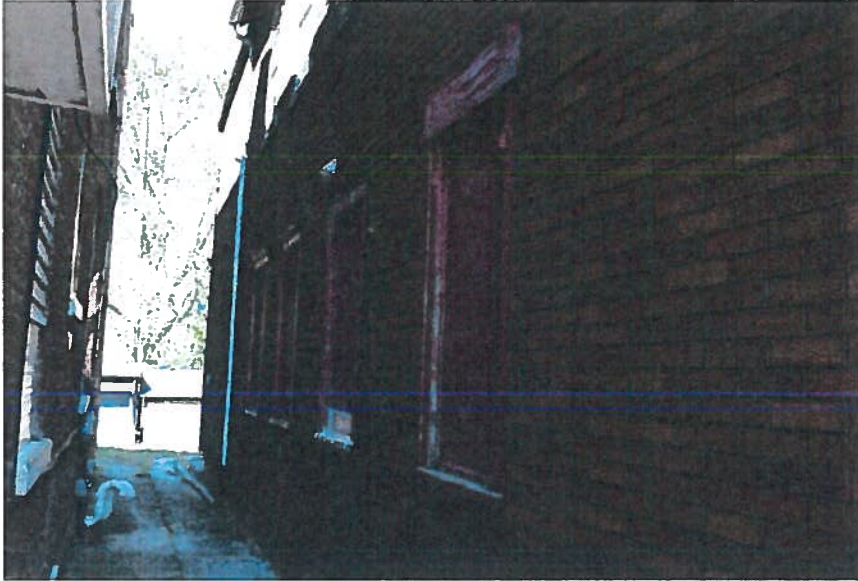
- Boarded up at exterior and interior so hard to determine exact existing conditions
- Paint peeling at exterior

Figure 2. Deteriorating side windows fronting onto alley.

(1) Removal of window infill and installation of new windows to match existing original

Regarding window size and style, two of the four window openings will be installed with new windows that match the sizing and design of the existing original double-hung wood windows. The other two windows will remain covered. None of these windows is highly visible from 4th Street.

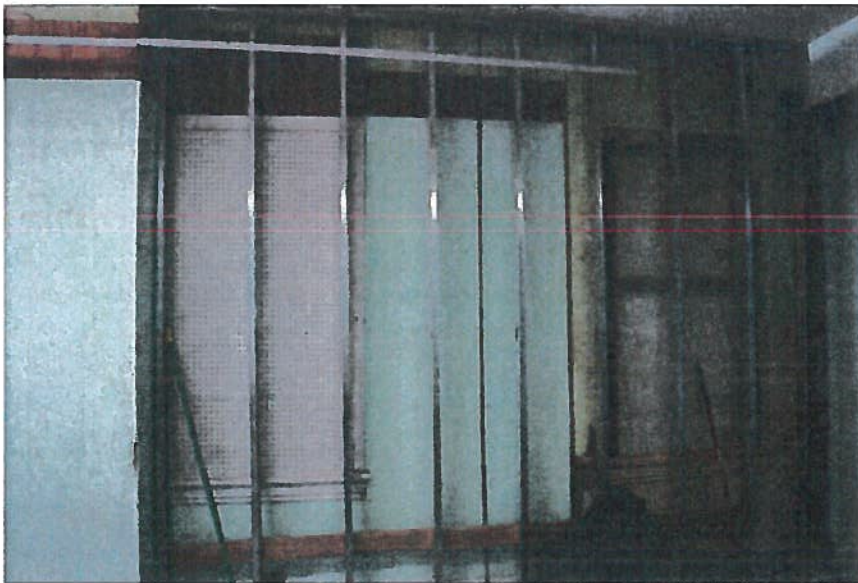
Figure 3. Interior view of existing windows (2 at north side closer to rear).

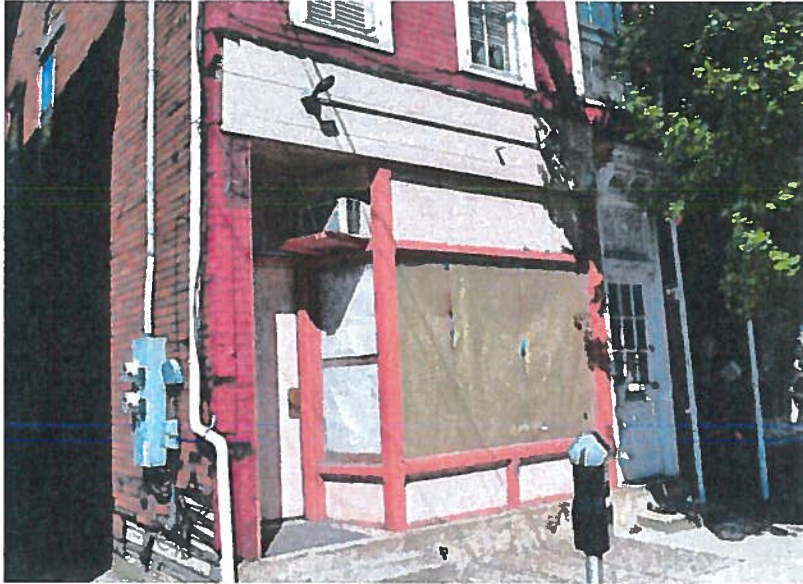
- Original transom boarded up at exterior and painted over at interior
- Wood sill appears to be capped with aluminum
- Original cornice element removed above window (still exists above single door at right side)

Figure 4. Overall view of storefront viewed from 4th Street.

- a. Removal of aluminum capping
- b. Removal of covering from original transom and repair as needed
- c. Restore cornice in wood to match existing above door (right side)
- d. Repair existing storefront door

The transom will be uncovered and restored as necessary and the cornice reconstructed to match the original portion at the right side. The original wood storefront framing will be uncovered, restored as necessary, and repainted. See photos of existing storefront transom and cornice above. The existing wood door will be replaced with a new wood or smooth fiberglass door with glazing.

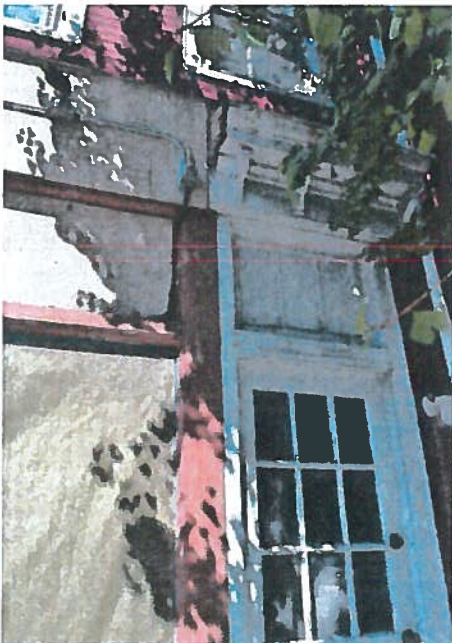
Figure 5. Close-up view of original transom and cornice that will be uncovered and reconstructed, respectively, above the storefront.

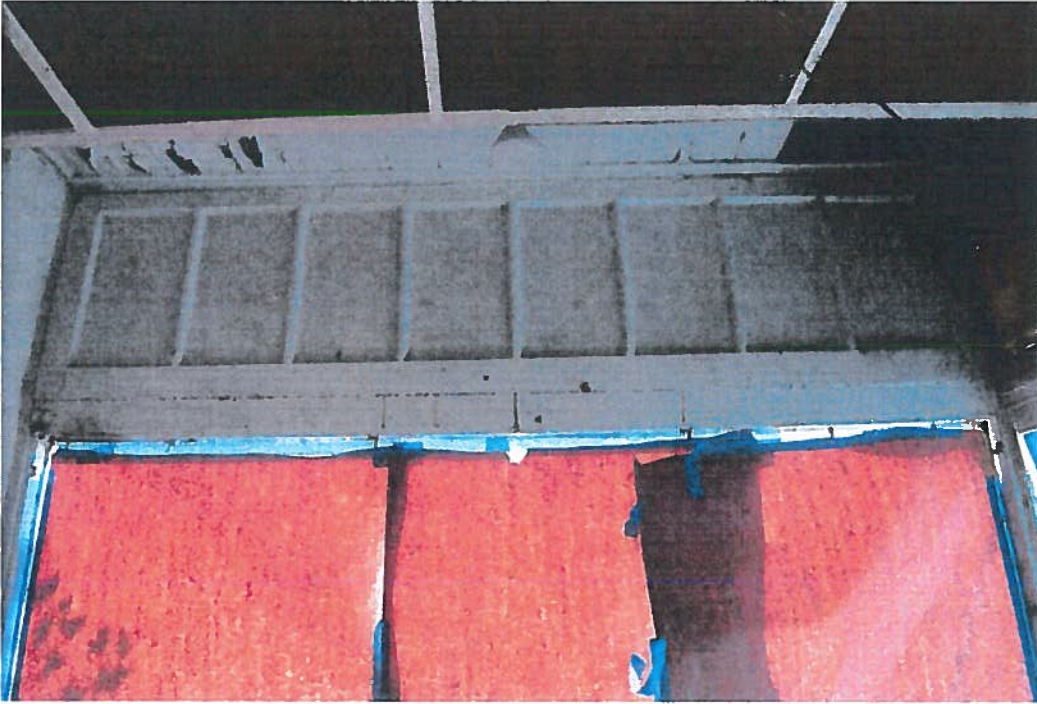
Figure 6. Close-up view of original painted-over transom at interior.

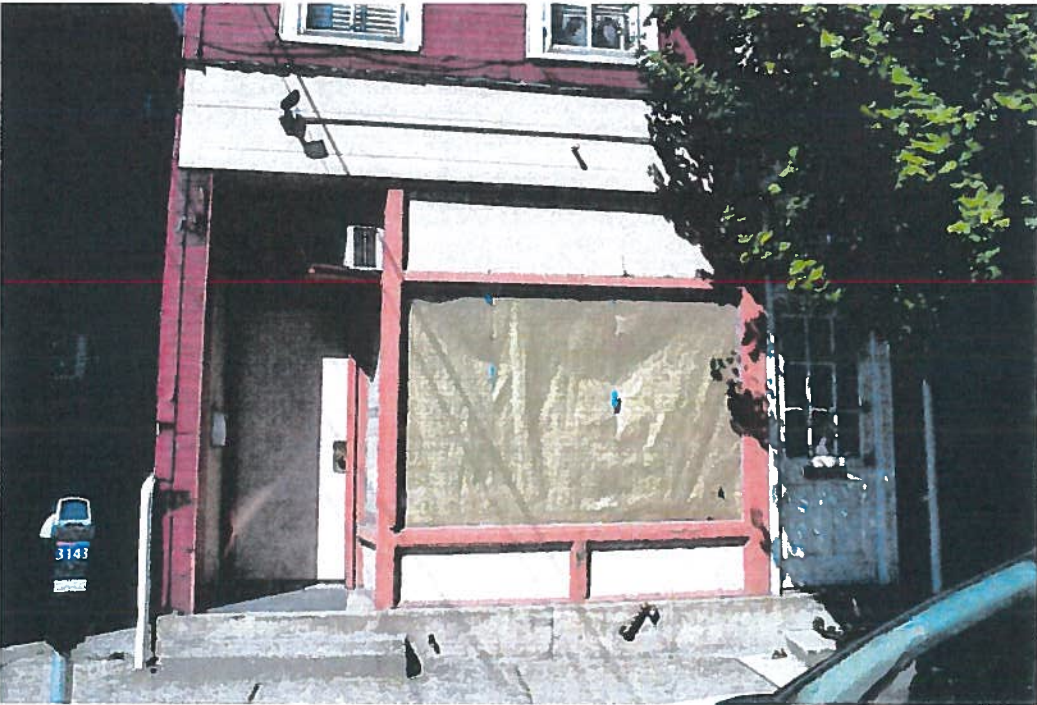
Figure 7. Overall view of storefront looking north.

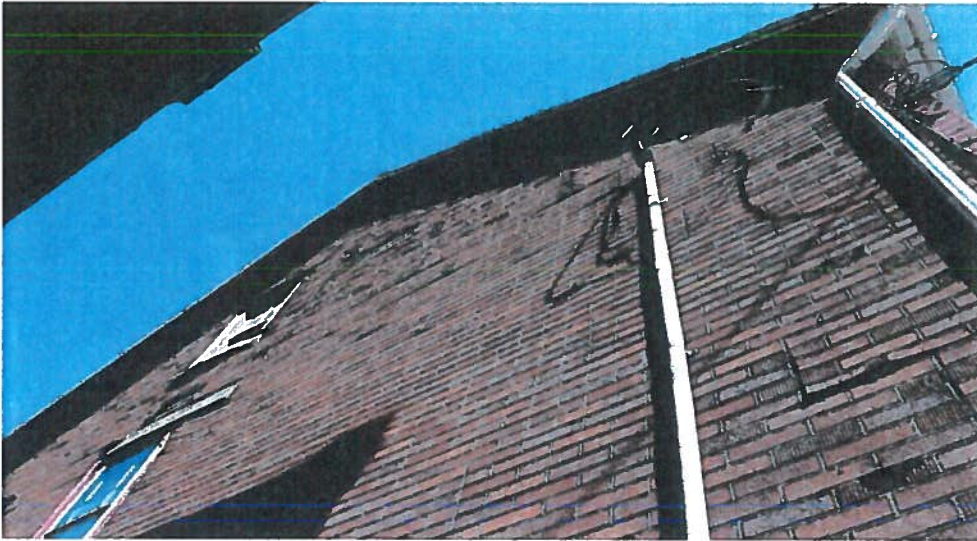
- Homasote-like imitation brick siding that is flaking in several places

Figure 8. Close-up view of deteriorating imitation brick siding, peeling off of original wood siding in various places.

Exterior homasote-like fiber cement siding is currently deteriorated and flaking off the facades, especially at the side and rear. It is proposed to uncover the original wood siding to determine its quality, repair, and paint if deemed to be in decent condition. If not, fiber cement siding would be installed. See photos of existing conditions above for reference.

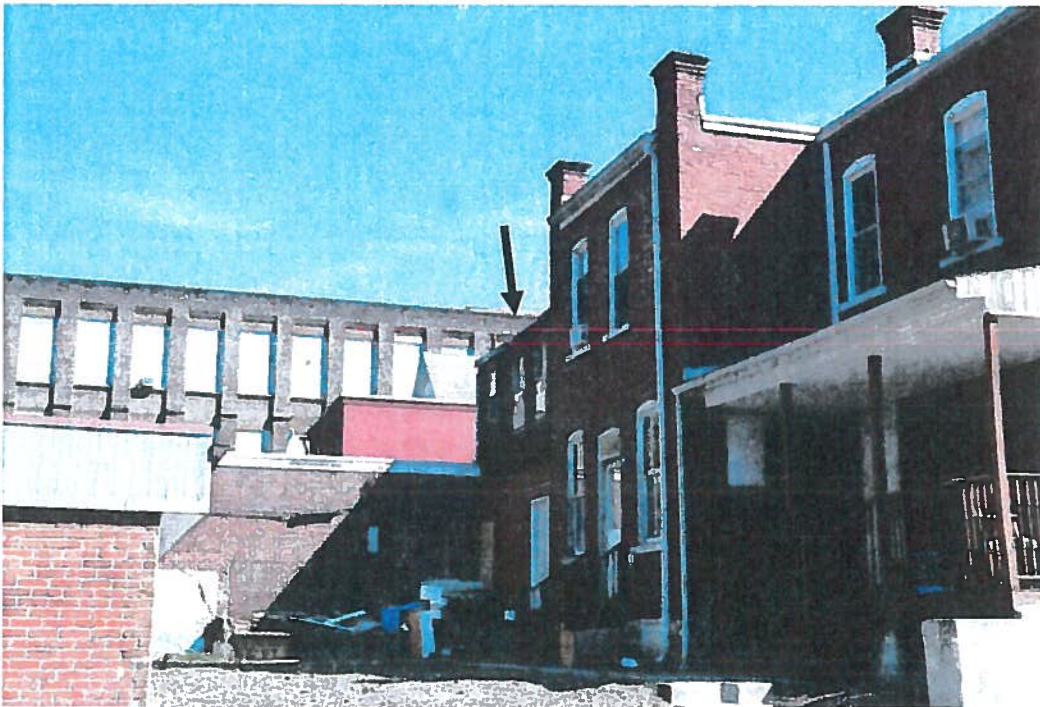
Figure 9. Partially visible view from Fillmore Street of rear façade (indicated with arrow).

(3) Removal of front, side, and rear façade imitation brick siding which is severely deteriorated (not highly visible from any public right-of-way)
