**APPLICATION FOR CERTIFICATE OF APPROPRIATENESS (COA)**

Building address 314 Broadhead Ave, Bethlehem PA. 18015  
 Owner of building Mish, Eugene B + Michael A. JTA Phone [REDACTED]  
 Owner's email & mailing address [REDACTED] 310 Broadhead Ave  
 Applicant Same Phone: Same  
 Applicant's email & mailing address Same  
Street and Number    City    State    Zip Code

# BASE ENGINEERING INC.

RE: 314-316 Brodhead Ave.  
Bethlehem PA  
Structural Assessment – Base Project No.: 2018-140

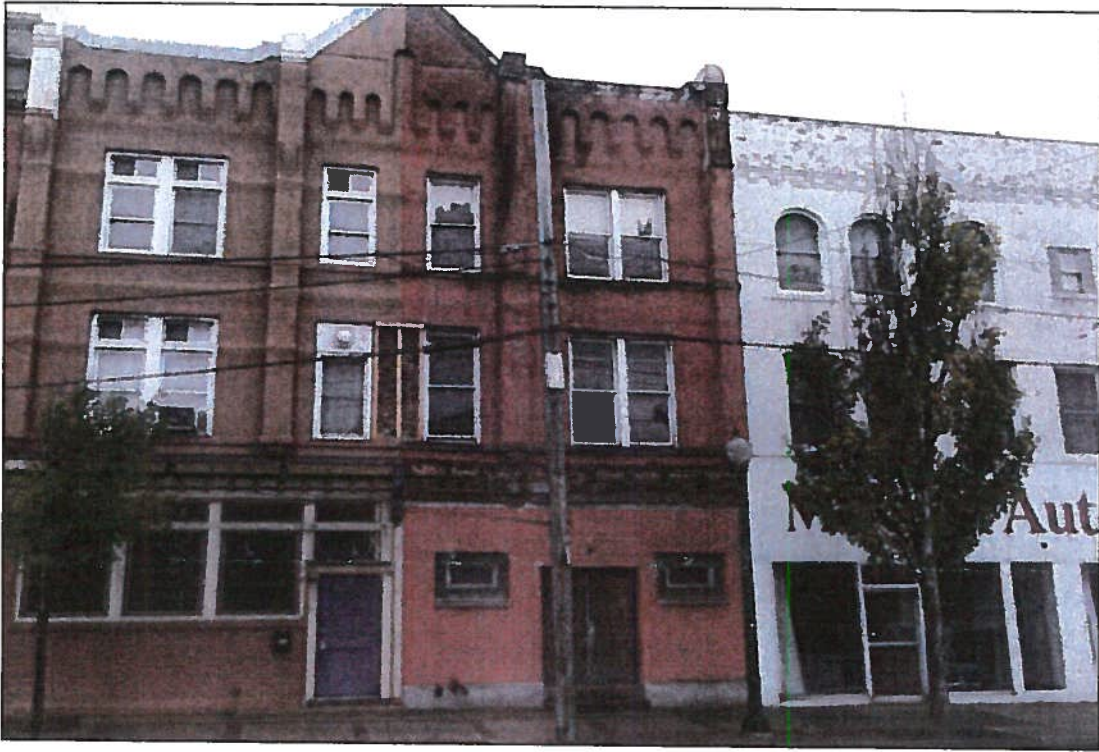
PHOTO 1

The building in question is a three-story, plus basement, historic commercial structure located in the downtown area of Bethlehem, PA (Photo 1). The three-story building consists of wood framed roof rafters/trusses and floor joists, supported by exterior multi-wythe brick bearing walls. Base performed a site visit to the property on August 1, 2018 to observe the condition of the building. Present at that time were Barry A Cohen, PE (*Base*), Philip Roeder, Commercial Building Inspector for the City of Bethlehem (City) and Gene Mish (Building Owner). The observations made were limited to visual assessments of the structural elements of the building only.

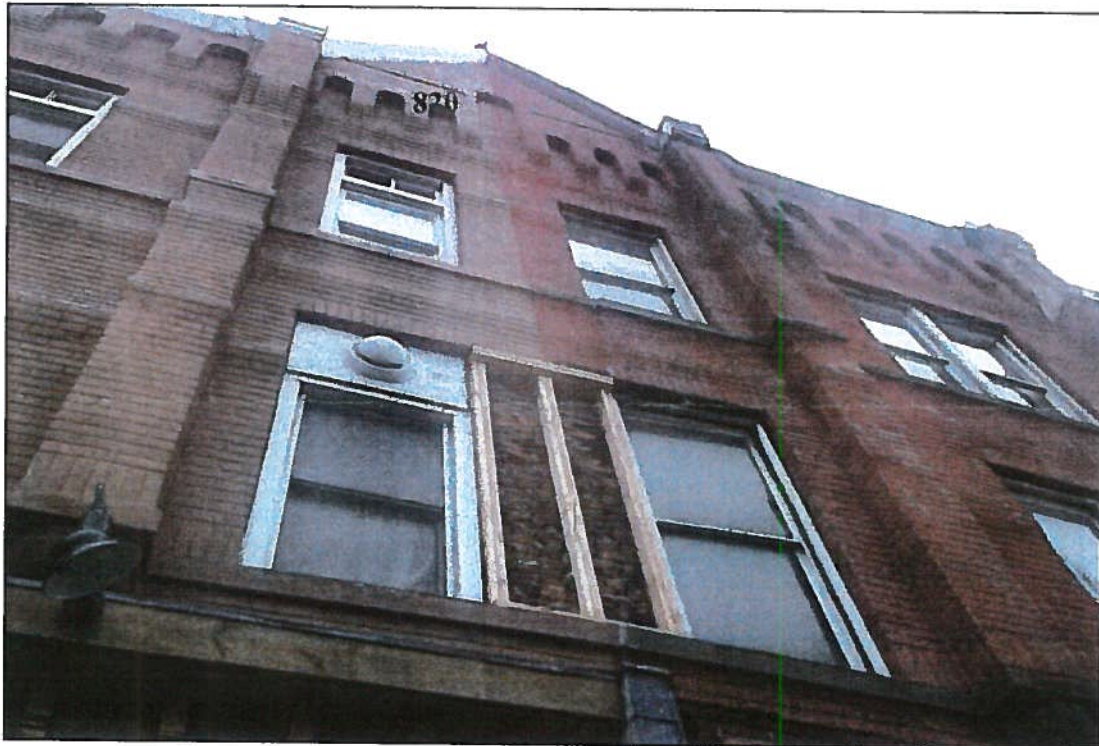
PHOTO 2

City of Bethlehem (the City) and the building Owner, it is our understanding that the building has been empty for several years. In addition, it is *Base's* understanding that a portion of the exterior brick failed and collapsed to the sidewalk below (Photo 2).

- Removal and reattachment of all loose brick, and re-pointing of existing loose and missing mortar. To prevent further deterioration, helical anchors should be utilized to tie the exterior grade brick on the outer wythe to the interior brick. This should occur over the entire face of the building. Additional distress may be found to the interior wythes of brick during this procedure, which will need to be addressed.
- Total removal and replacement of the exterior brick, including new, code-approved masonry anchors. Additional distress may be found to the interior wythes of brick during this procedure, which will need to be addressed.
- Removal of the entire wall (all wythes) and replacement with a new stud wall and a brick veneer. If this method is chosen, then the full survey of the façade is not necessary.

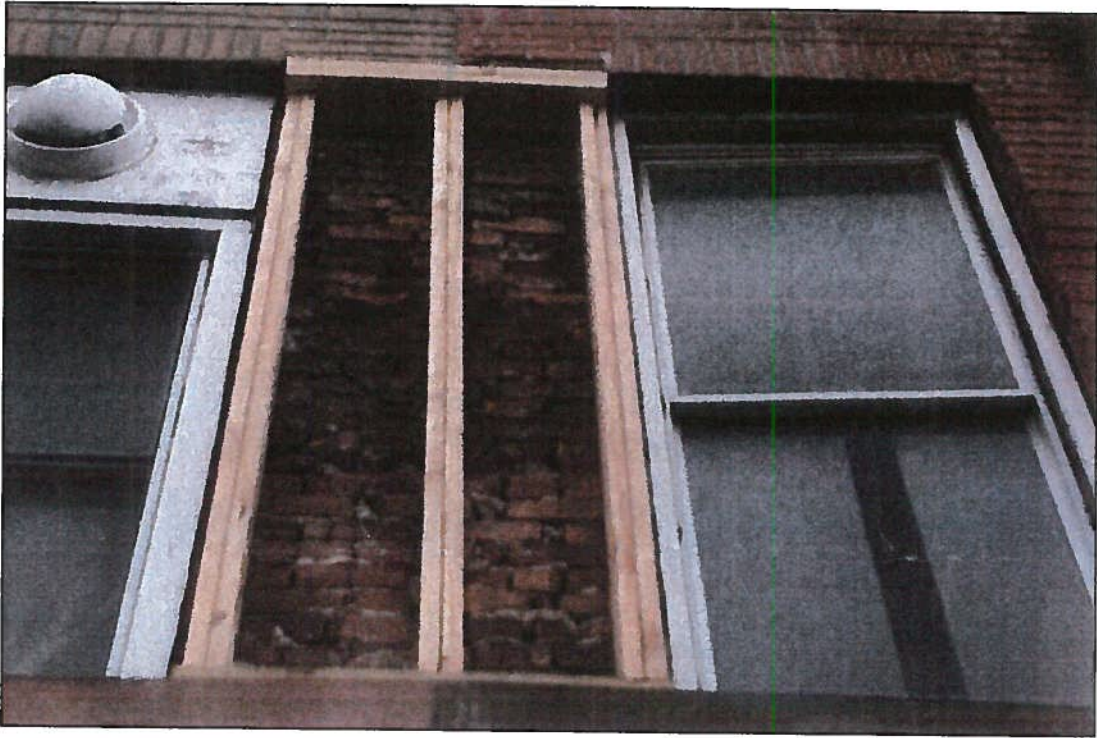
**PHOTO 3**

The wall appears to consist of multi-wythe brick, with the exterior grade brick the components which failed. Based upon the limited observations made in the area of the failure, there appears to be minimal connection of the various wythes of brick (Photo 3), either with header brick (brick installed at a 45° Angle, or metal brick ties. If ties existed, they have more than likely deteriorated at this time and are ineffective.

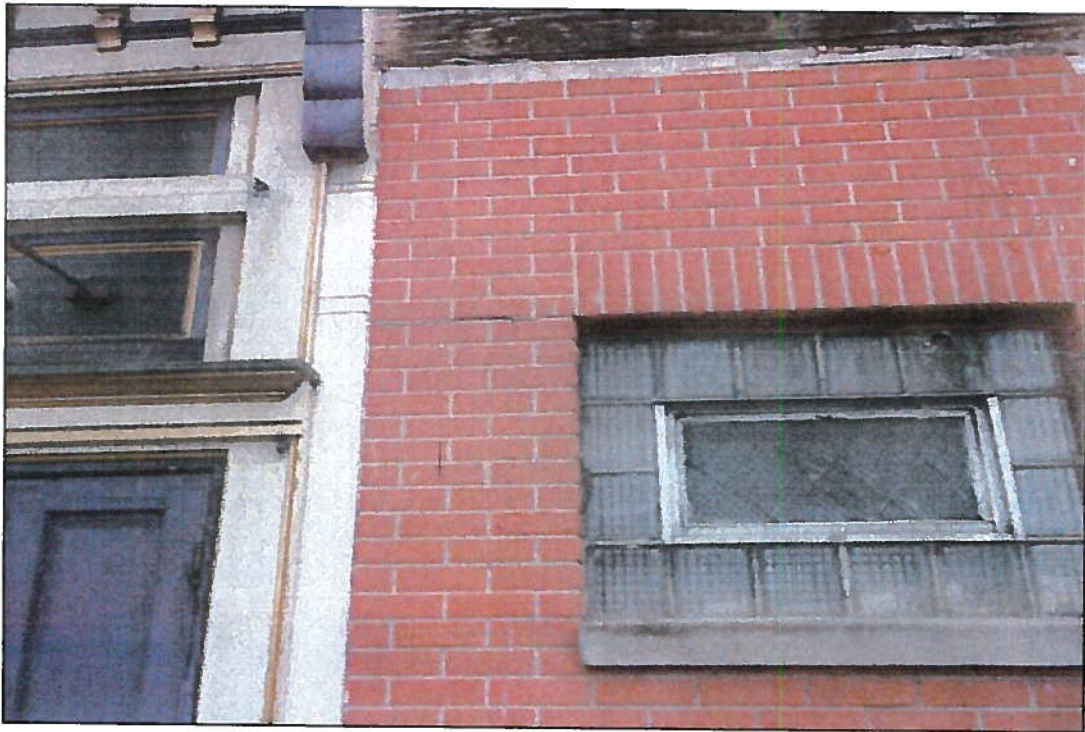
**PHOTO 4**

Several large cracks were visible along this wall (Photos 4 to 6), which is an indication that further deterioration of the wall is not only possible, but probable.

The main structural concern with the building, which precipitated this investigation, was the integrity of the exterior brick. The east wall of the building shows severe signs of distress in areas other than the collapsed area, and it is reasonable to assume that the deterioration is not limited to the areas of current failure. The lack of ties for the entire brick wall is likely typical for the entire east façade. Therefore it should be assumed that without remedial procedures, additional portions of the wall will collapse. In our professional opinion, it is not a question of if a collapse will occur, but when it will occur.

The entire building façade should undergo a full, in-depth study to determine the condition of the entire façade – The observations made during this investigation were limited to those elements and components that were readily visible from the street. Utilizing a lift to perform a full survey of the wall will most likely reveal further deterioration and areas of distress. Once this survey is complete, a remediation/repair plan can be developed to repair the damaged wall. In general, this remediation can occur in one of three general methods:

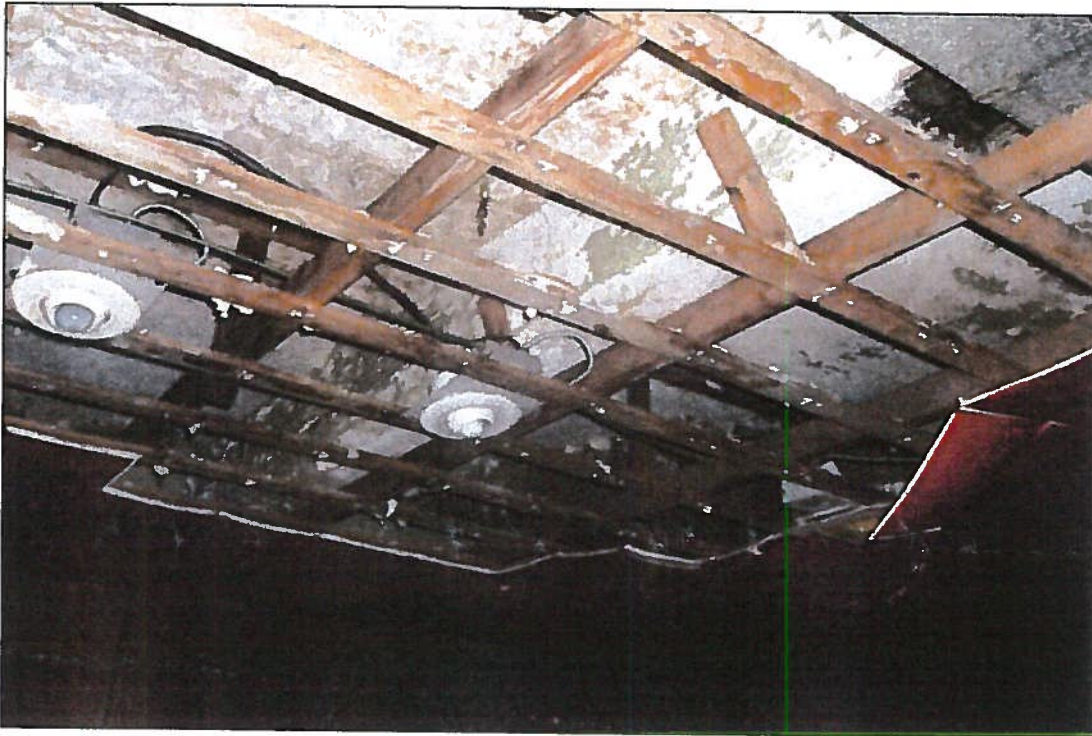
**PHOTO 7**

Observations were also made on the interior of the building, on all three floors. (Photos 7 thru 12) The general condition of the floor and walls was good, with what appears to be minimal loss of structural integrity, other than what one should expect from a building of this age, and lack of maintenance. The roof structure exhibited severe signs of distress due to exposure. Water damage was extensive throughout the building.
