APPLICATION FOR CERTIFICATE OF APPROPRIATENESS (COA)

PROJECT: Hispanic Center Lehigh Valley
520 E. 4th Street, Bethlehem, PA

**RE: HOUSE SURVEY OF EXISTING CONDITIONS
520 E 4TH ST, BETHLEHEM, PA 18015**

Re: Hispanic Center
520 East Fourth Street
City of Bethlehem, Northampton Co., PA

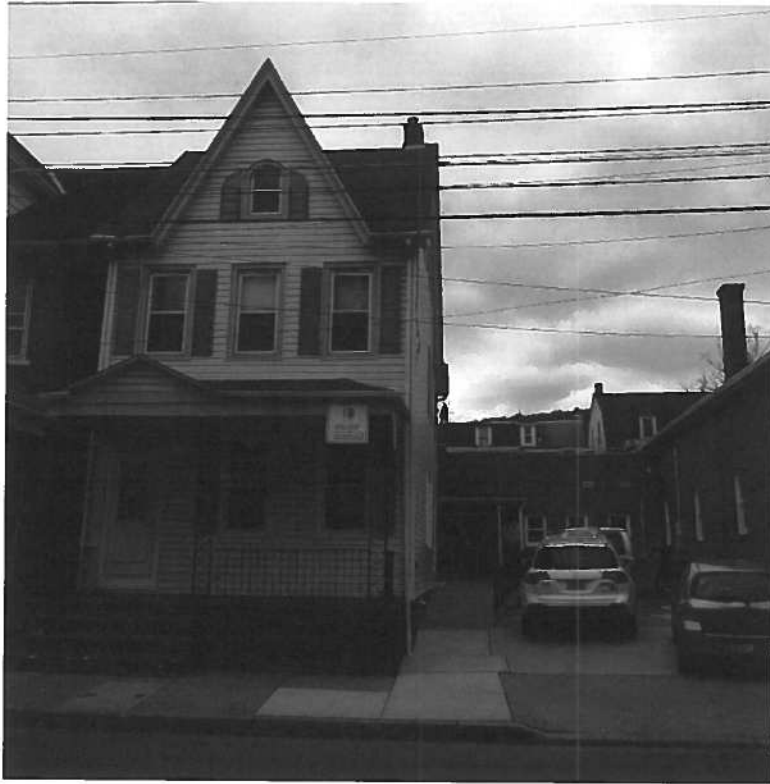
Photo 1

The house (approximately 17'x40') is a three-story wood framed structure with vinyl siding, a full basement, rubble stone foundation walls (See Photo 1). The 2x first, second floor and attic joists span the short direction (East to West) of the house. The main roof has a A frame running east to west in the middle with a dormer out the front (North) and a reverse A in the back (South) of the house.

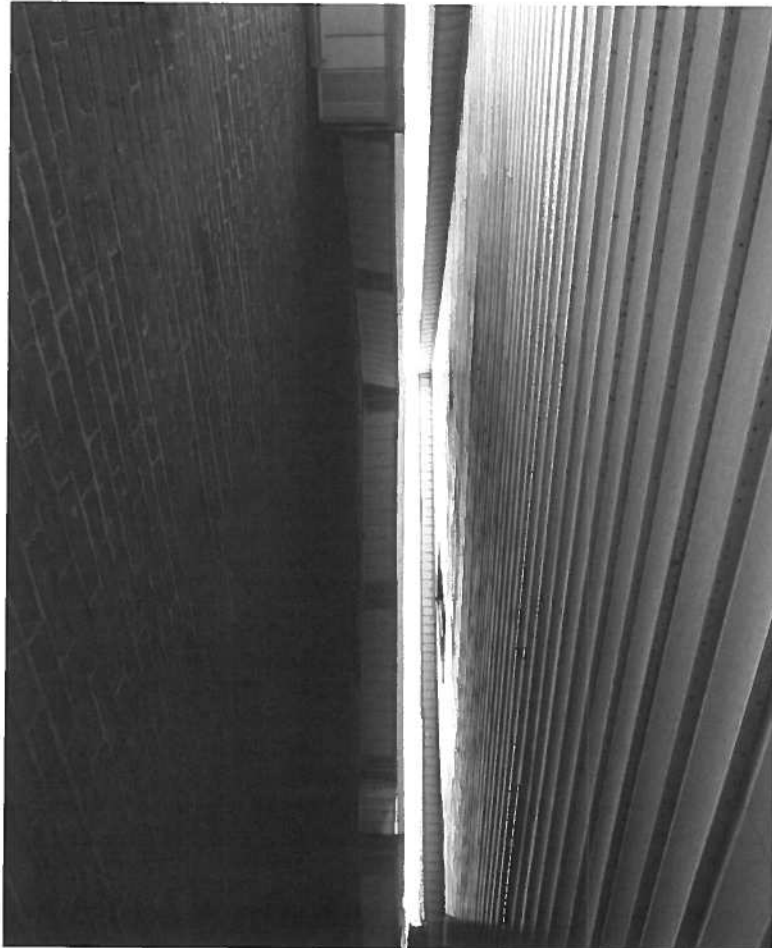
Photo 2

The observations from the exterior were limited due to the vinyl siding covering the exterior façade. We did observe that the gable end on the west side of the main roof was pushed outward toward the adjacent property (See Photo 2). This was further investigated in the attic and is discussed later in this report.

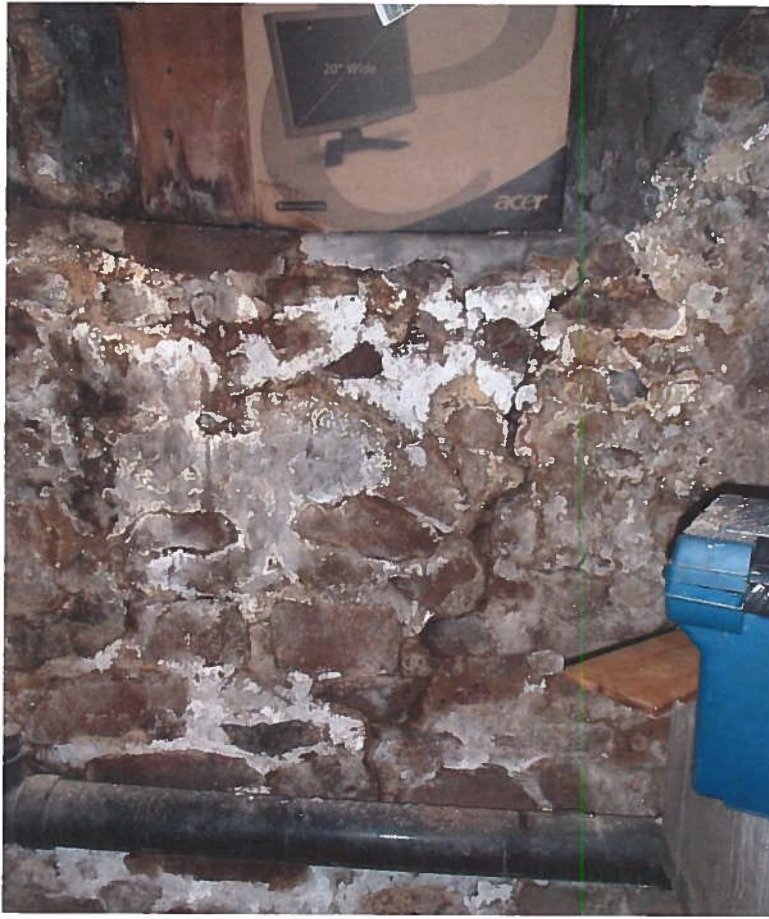
Photo 3

The basement foundation wall is constructed of rubble stone. A crack was observed at the corner of an opening in the foundation wall (See Photo 3)

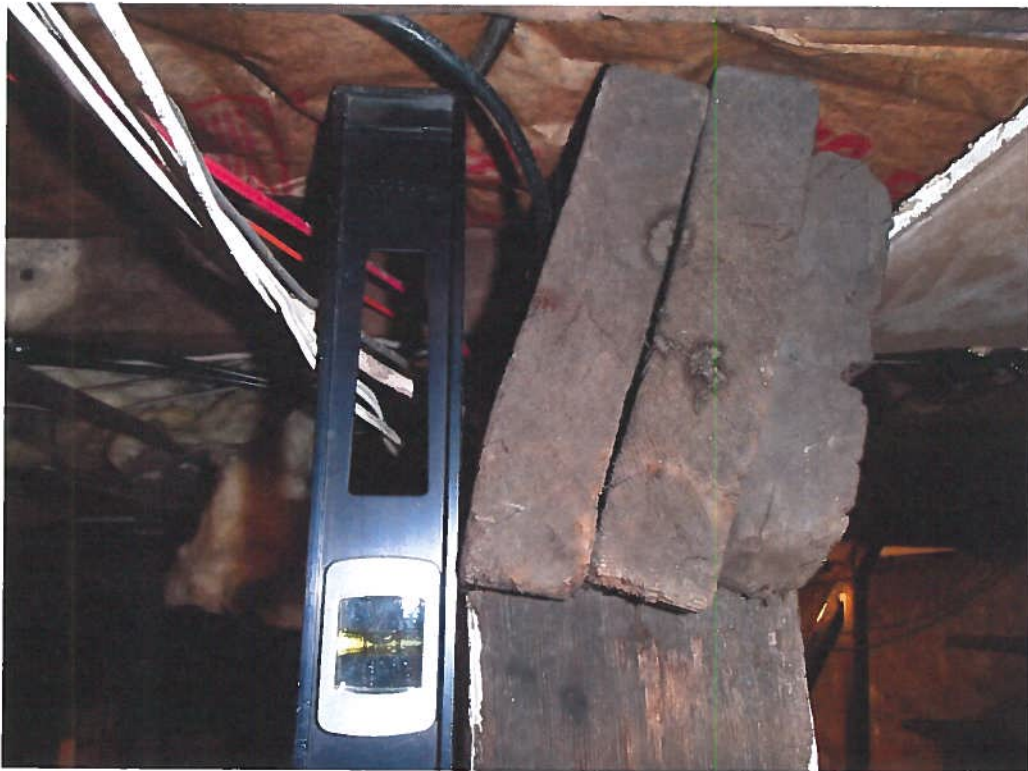
Photo 4

The first-floor framing was observed from the basement. There were 2"x 9.5" joists at approximately 18" o.c. spanning east to west. There was a beam supporting the first-floor joists at the front 27' of the basement. Where the triple 2x beam stopped it was supported by a wood post. The wood beam rotated significantly (See Photo 4). Additionally, the wood post at this location was out of plumb (See Photo 5).

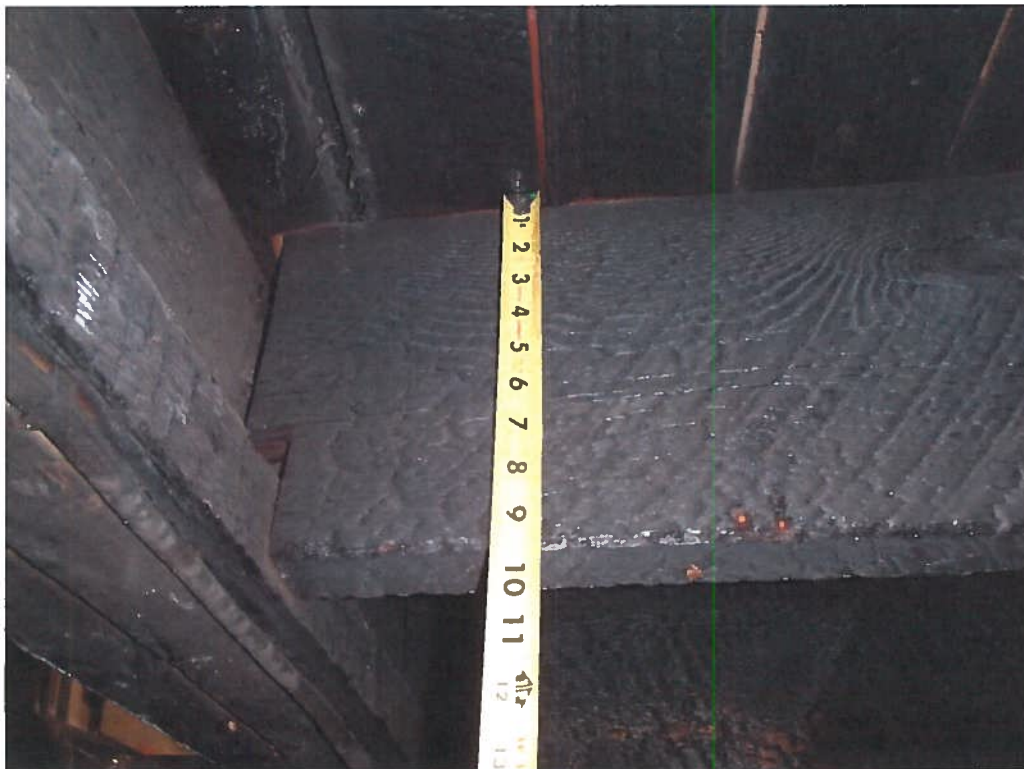
Photo 6

Adjacent to the floor opening for the stair at the first floor framing it was observed that a fire had previously occurred, and charring was present on the floor joists (See Photo 6). At one location we noted a floor joist had metal ties installed to laterally brace the floor beam at the edge of the stair opening (See Photo 7). The second floor framing adjacent to the stair opening also had two metal ties installed at the floor joist and the 2x beam framing the stair opening (See photo 8). The metal ties were installed to limit the rotation of the beam at the edge of the framing around the stairs.

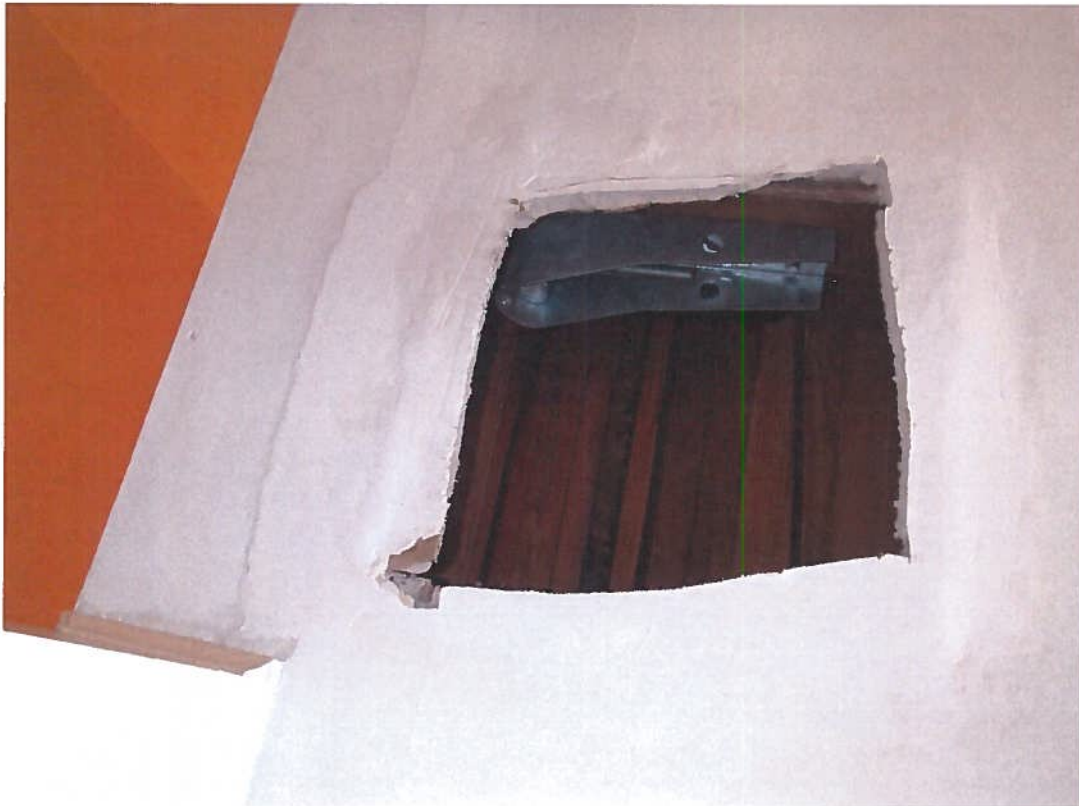
Photo 8

At the second floor we noted that the bathroom and office at the south end of the structure, along with the hallway in this area, was not level and appeared to be sloping toward the interior of the building. Settlement cracks were observed at the second floor finishes consistent with the observed floor settlement. Additional finish cracking was noted at the north end of the second floor.

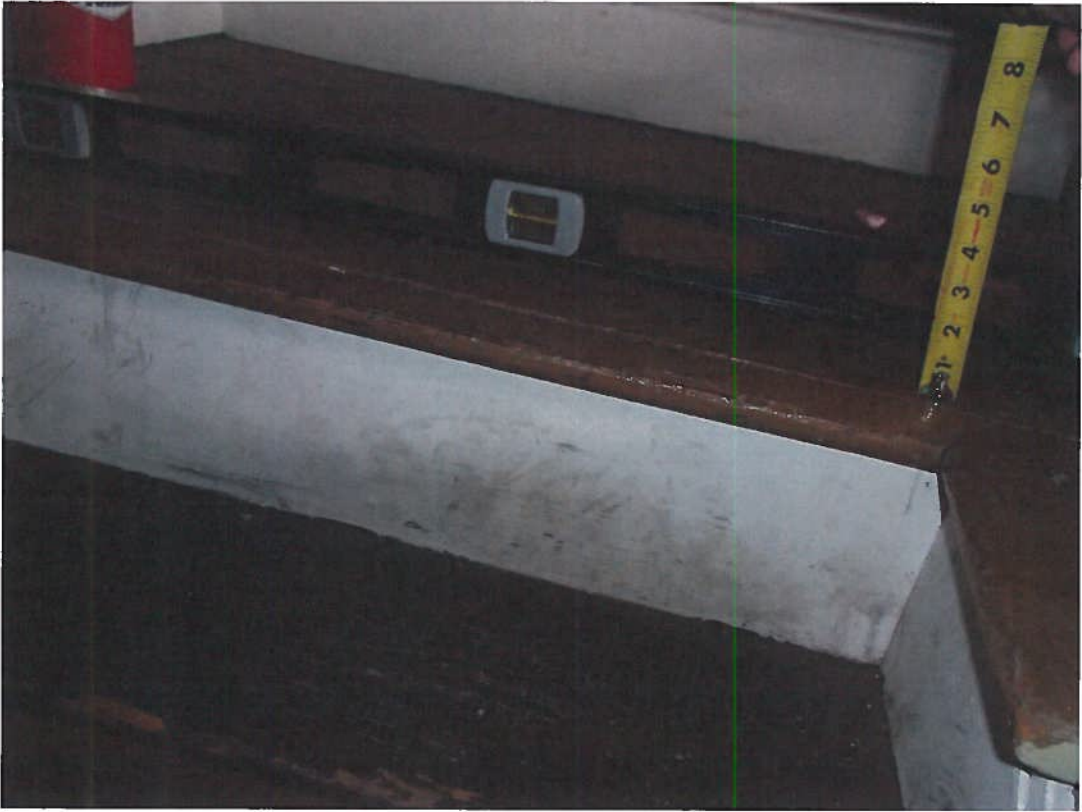
Photo 9

At the top of the stairs to the attic a level was used to determine the levelness of the floor. We measured the floor to be out of level approximately 1.75" over 4' (See Photo 9). Significant cracking was observed in the finishes in the attic and some of the cracking appeared to be recent (See Photo 10). At the ceiling of the attic space we noted irregularity of the ceiling finishes which was consistent with the settlement/movement in the structure previously noted.

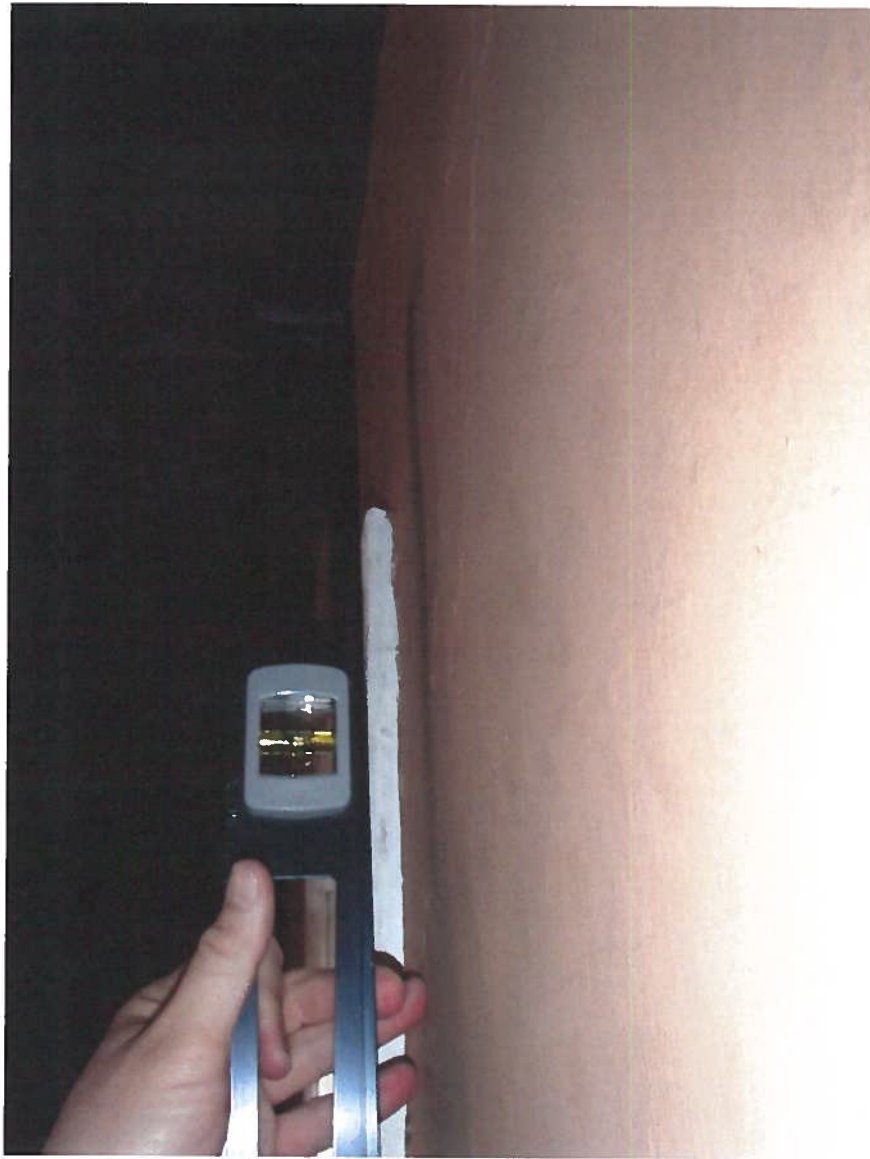
Photo 11

The west gable end wall at the attic was out of plumb approximately 1" over 4' (See Photo 11). This movement was visible from the exterior of the building as noted earlier in this report.

Based on our observations, there are structural deficiencies in the house structure which require repair to provide a safe building. Significant work would need to be performed to brace the walls and framing, level the floors, and address the many cosmetic and finish issues created by the structural deficiencies. The work to repair the structure would likely exceeded the value of the structure.

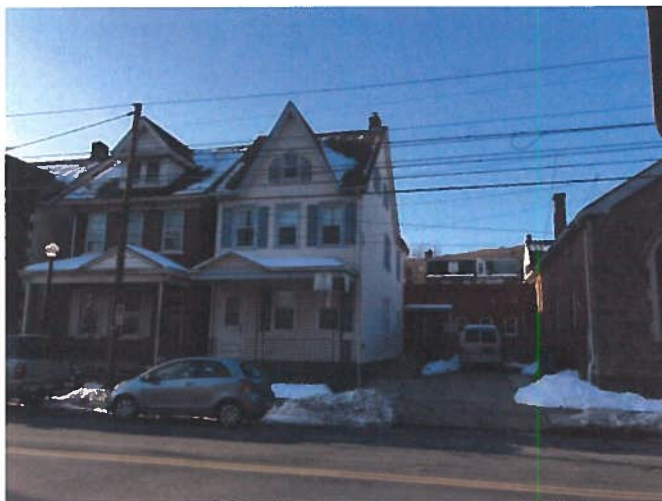
Photograph 1

Showing the Hispanic Center including stone structure to right side of picture, house to left side of picture and brick connecting structure between to the rear

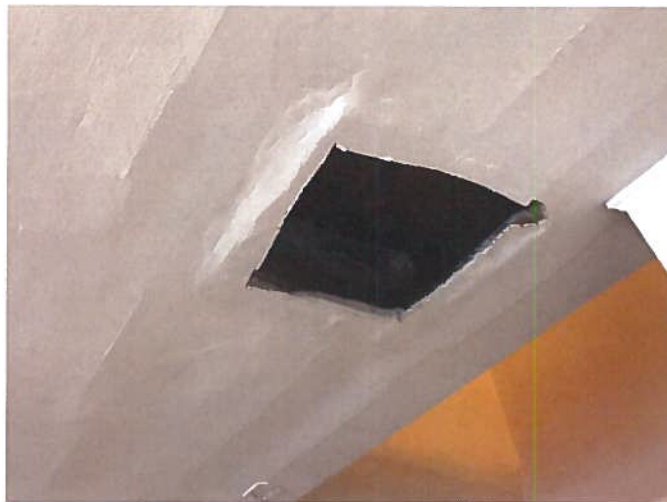
Photograph 2

When looking throughout the existing converted home, there were **several concerns noted particularly the unevenness of the first floor**, particularly where the house connects to the brick structure to the rear as result of settlement of the house since constructed in 1935. Also this continues throughout the house wherein method's of structural repairs were made to stabilize the wood framed structure inclusive of Simpson Strong-Ties with thread rods were previously installed at the stairway to the second floor as can be seen in Photographs 2 and 3 below.

Showing Simpson Strong-Tie installed in first floor ceiling at stairway to 2nd floor.

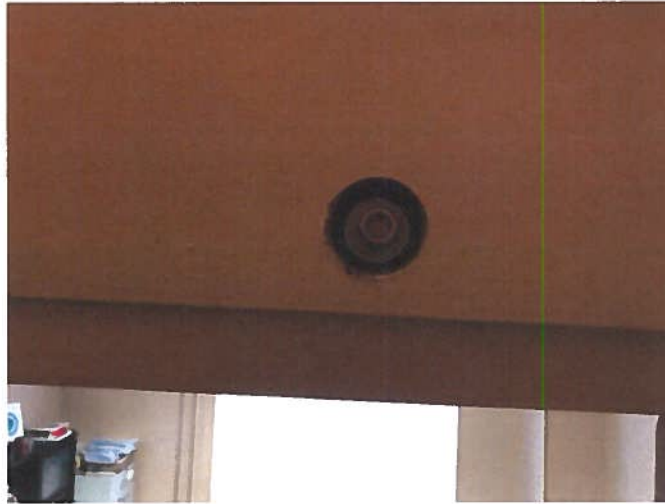
Photograph 3

Showing exposed threaded rod and nut from Simpson Strong-Tie at the stairway.

Concern noted is the longevity of the repair and likelihood that further additional repairs needing to be made as structural settlement progresses. While walking around the attic/3rd floor area the sagging of the ceiling was noted as shown in Photograph 4 below.

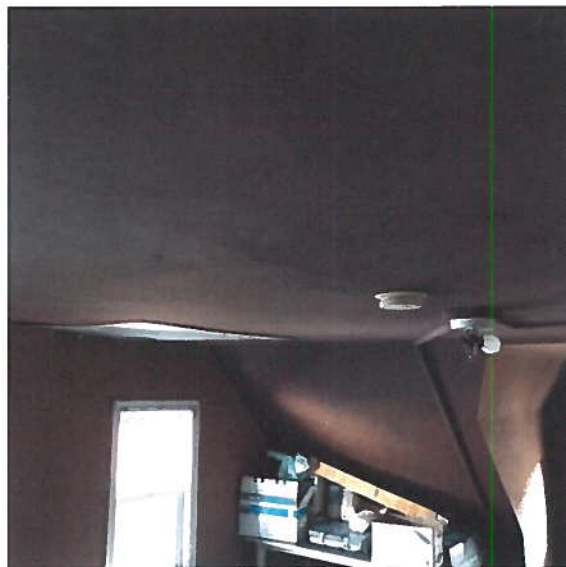
Photograph 4

Showing sagging/bulging downward of ceiling at the center of the picture and above the window at the left of the picture.

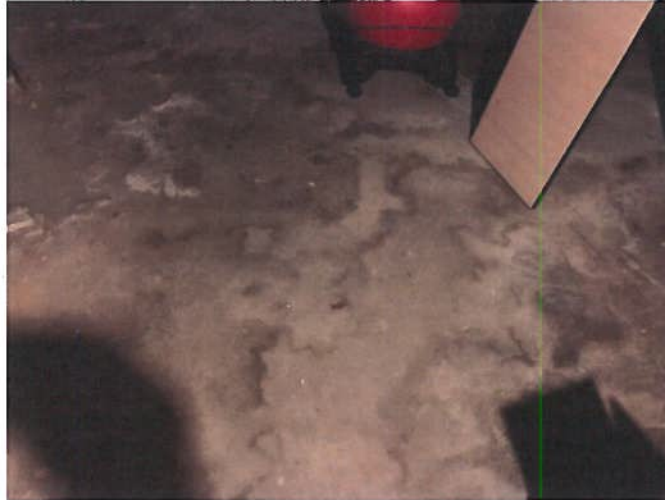
Photograph 5

Showing water staining on the concrete basement floor.

Water staining is a result of water infiltration indicative of a lack of waterproofing/damp proofing on the exterior of the basement walls. The lack of damp/waterproofing is typical with many buildings constructed during that time period.

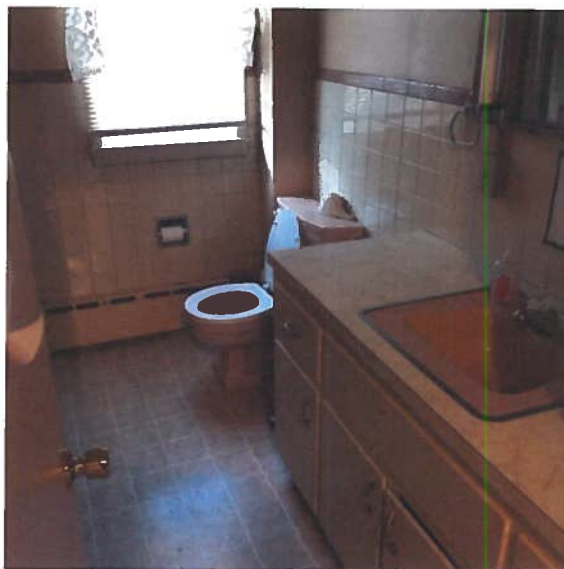
Also noted when viewing the restroom in Photograph 7 below is the **lack of ADA required accessibility.**

Existing restroom w/o grab bars, etc.

Obviously with any renovations to the facility, upgrades will be required to the wiring to conform to current building codes as well as the expenditure of up to 20% of renovation costs to make the facility ADA accessible.

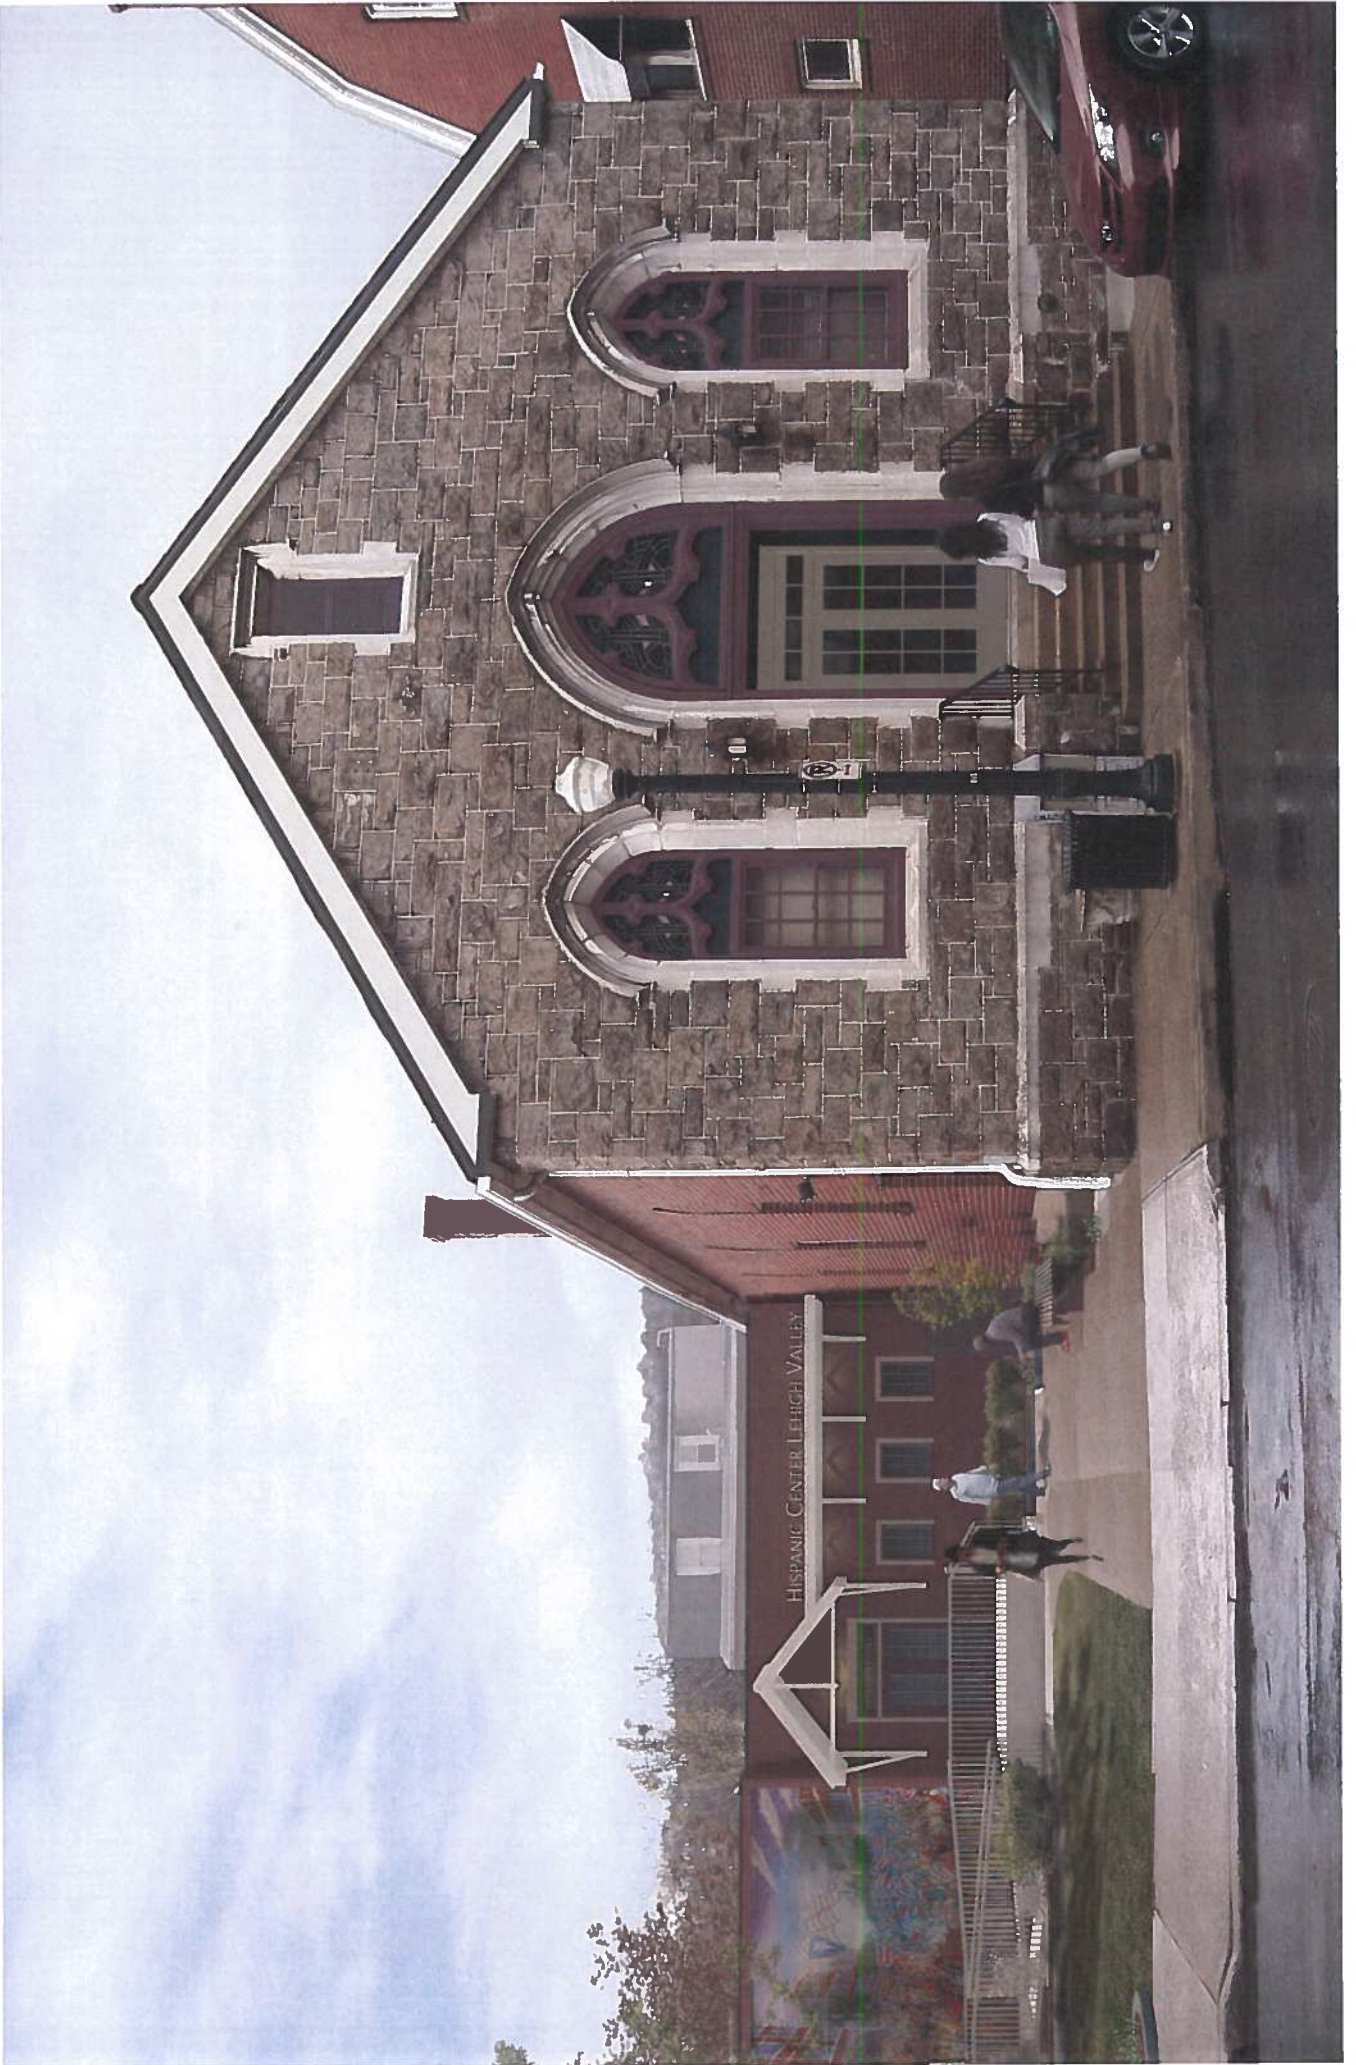
Exhibit F-1

- a. Submitted for consideration: Refer to Exhibits F-1, E-1
 - i. The former church on the west side of the property, made of stone and brick construction, resides on approximately 1,750 square feet and displays numerous historically significant architectural details including a stone façade, limestone window sills and jambs toothed into the field stone, and pointed Gothic arches with intricately crafted stained glass windows and mullions. All of the above are proposed to be restored and all wood trim to receive new paint (Sherwinn Williams - Historic Collection – Polished Mahogany and Wickham Grey)

- ii. These pointed Gothic arches are mimicked with brick at all other windows within the masonry construction of the former church and all windows and doors within the connecting rear portion of the property. All brick and faux arches will be retained or restored as required. This connecting portion, of steel and masonry construction, is located on the south side of the property and resides on approximately 2,848 square feet.
