APPLICATION FOR CERTIFICATE OF APPROPRIATENESS (COA)

Building address 25 W 3rd St #300, Bethlehem, PA 18015
Owner of building ArtsQuest; Kassie Hilgert, President & CEO Phone
Owner's email & mailing address
Applicant MKSD architects; Todd Chambers, AIA Phone
Applicant's email & mailing address
Street and Number City State Zip Code

COA — DEMOLITION OF EXISTING BUILDINGS (6 Separate Buildings/Structures)

COA — CONSTRUCTION, ARTSQUEST SOUTH BETHLEHEM COMMUNITY CULTURAL CENTER

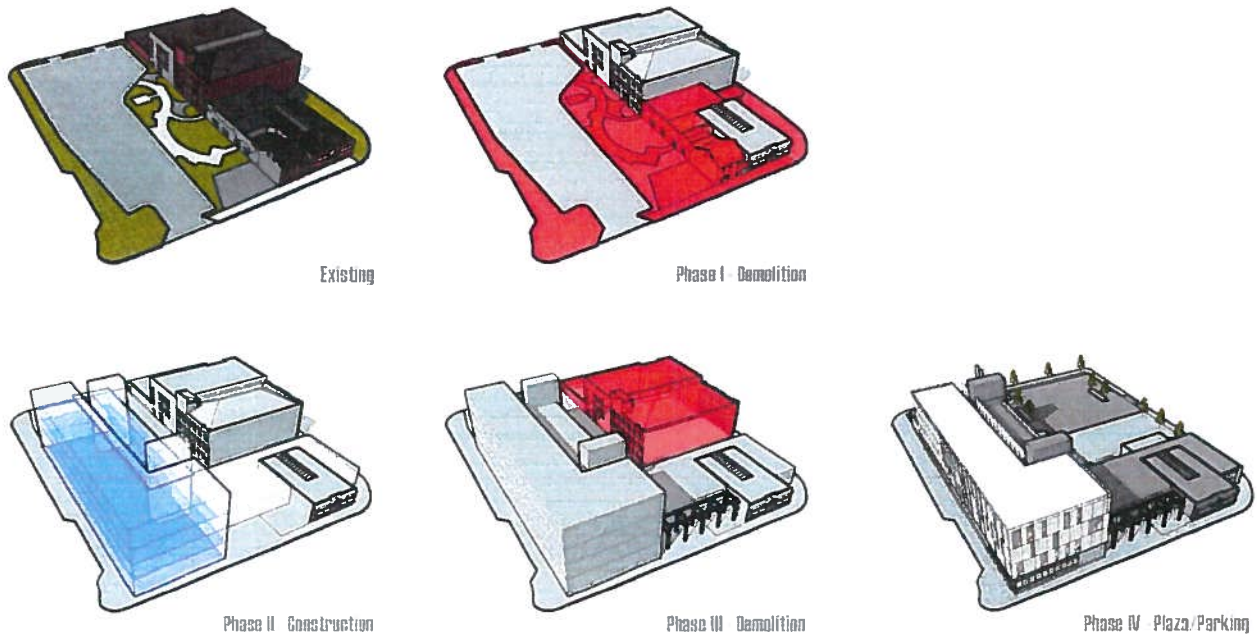
ArtsQuest South Bethlehem
Phasing & Massing

new facility on the rear portion of the site was explored and again it was determined that it was not ideal because the existing building would need to be completely vacated and temporary facilities procured for the building’s occupants. The final, most feasible option for addressing the existing facilities shortcomings is to selectively demolish portions of the building along 3rd street while the existing 3 story sections of the existing complex remain occupied during the construction of the new facility over areas of the parking lot and along the newly cleared space along 3rd street.

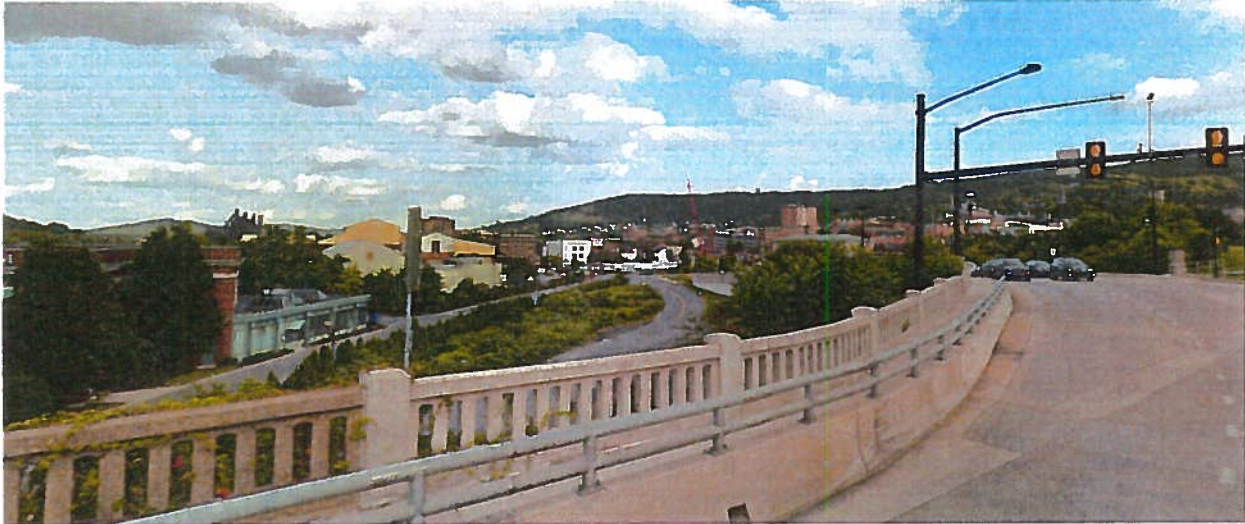
Below: Continuing down the 2nd Street Ramp toward the East, the building becomes more visible before it is concealed by vegetation on the Weldship site.

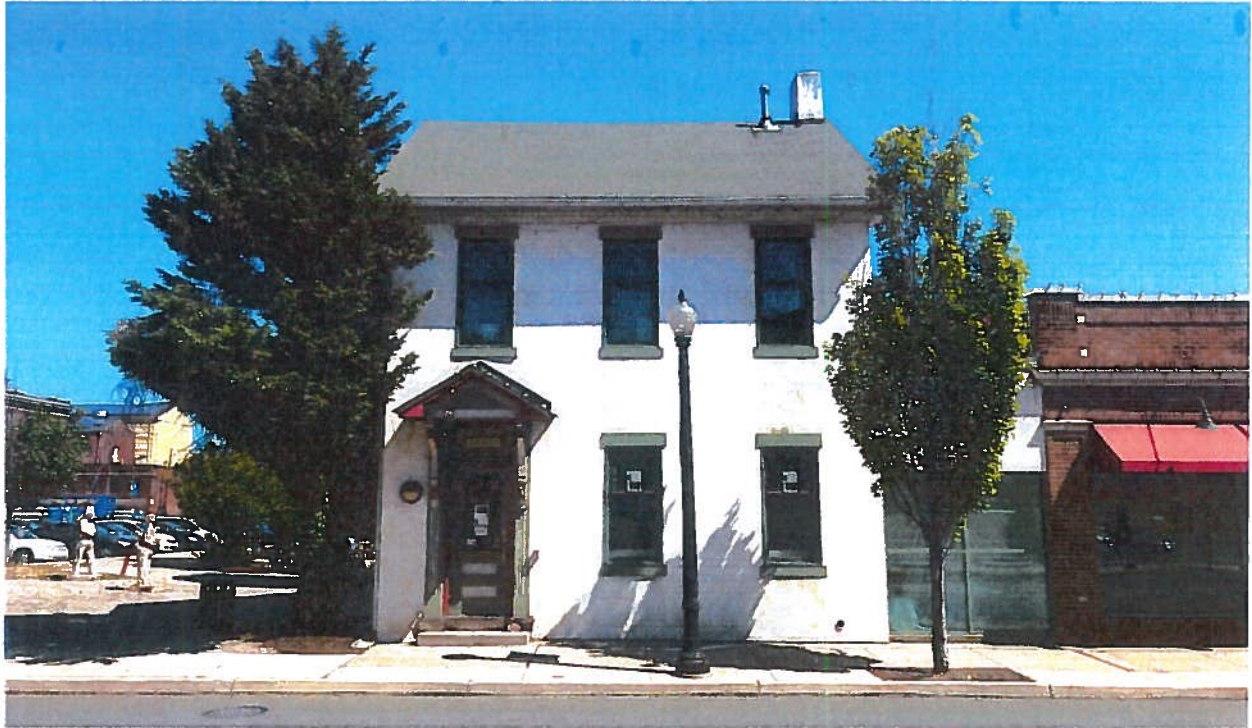
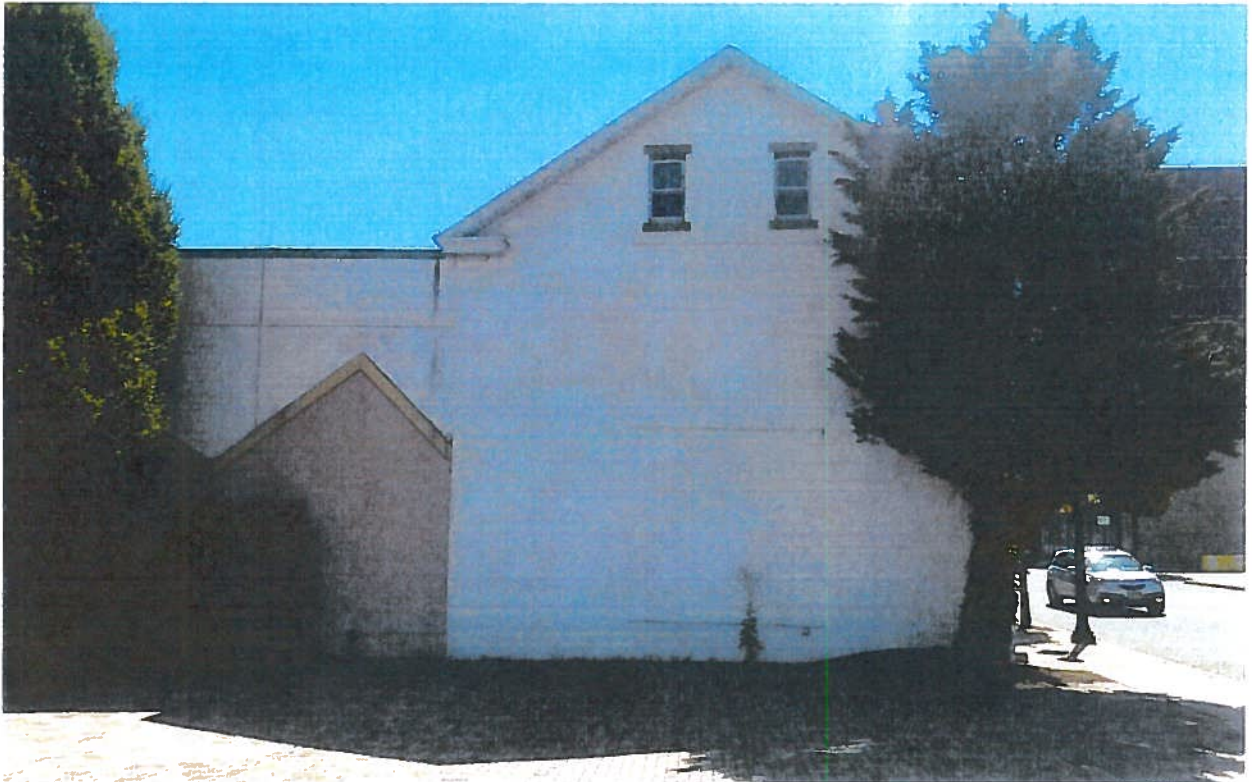
The house is now stuccoed but retains an historic entry and entry roof. The historic windows were replaced on the front façade with inappropriately divided double hung windows, although the side bay window seen in the 1897 Sanborn Map is still visible on the east upper level façade. There are no historic associations of importance found to date for the property.

Above: 3rd Street elevation (southern exposure), Below: Parking lot elevation (western exposure)

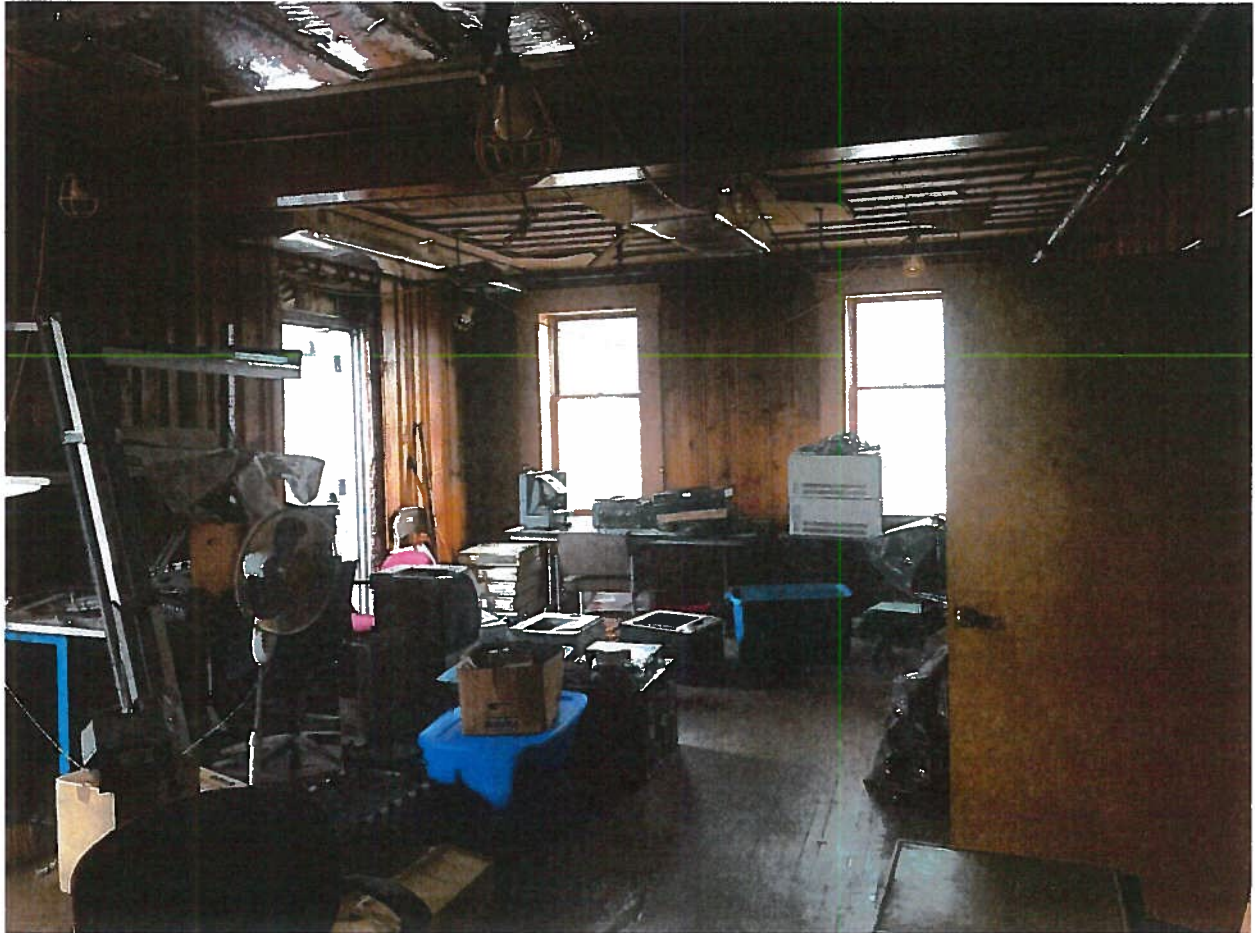
The current condition of this section of the facility is not favorable to reuse:

1. There are structural issues with the foundation and roof
2. Fenestration has been removed completely from the western facade
3. Water has and continues to infiltrate the structure through the roof during certain weather patterns
4. The façade is falling apart
5. Original details have been removed, covered, and/or bastardized through previous projects

The interior of this building was converted to commercial use in the 1990s. Currently, the lower level is an art gallery and the upper level is in disrepair as it was converted to mechanical and storage space.

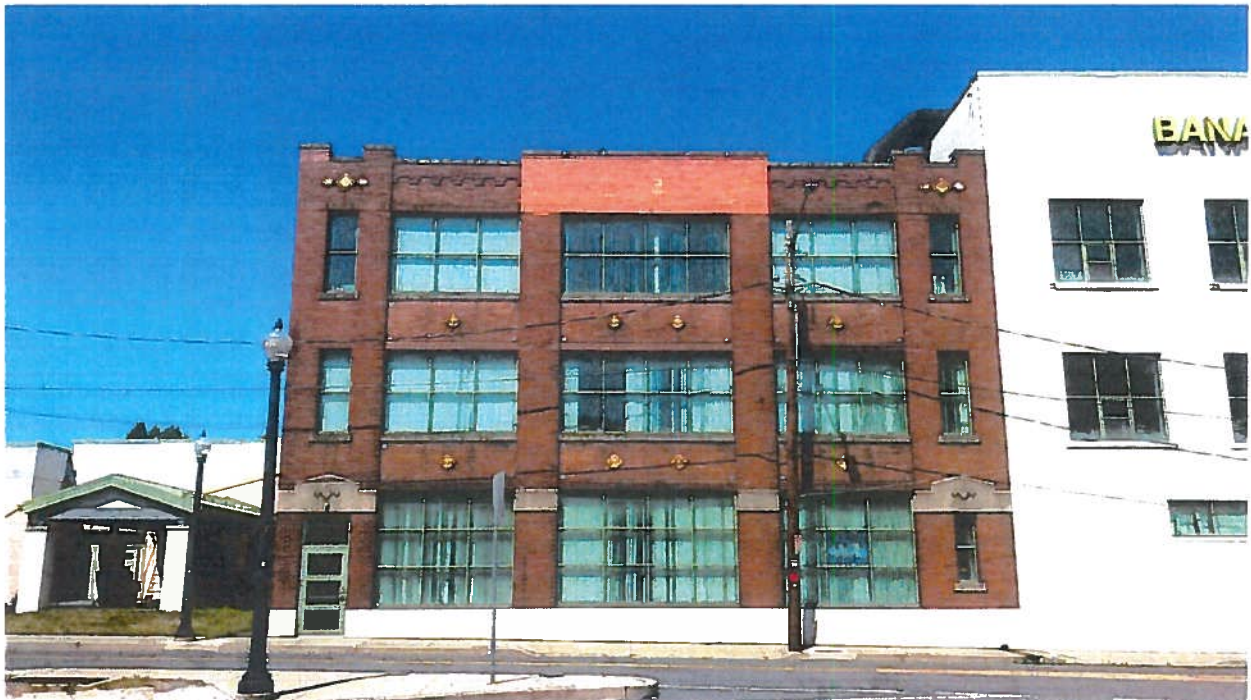
Above: Northampton Street elevation (eastern exposure)

The building has undergone some alteration, primarily when renovated by the Banana Factory, but retains integrity. Windows have been replaced and the center raised parapet reconstructed with non-matching brick.

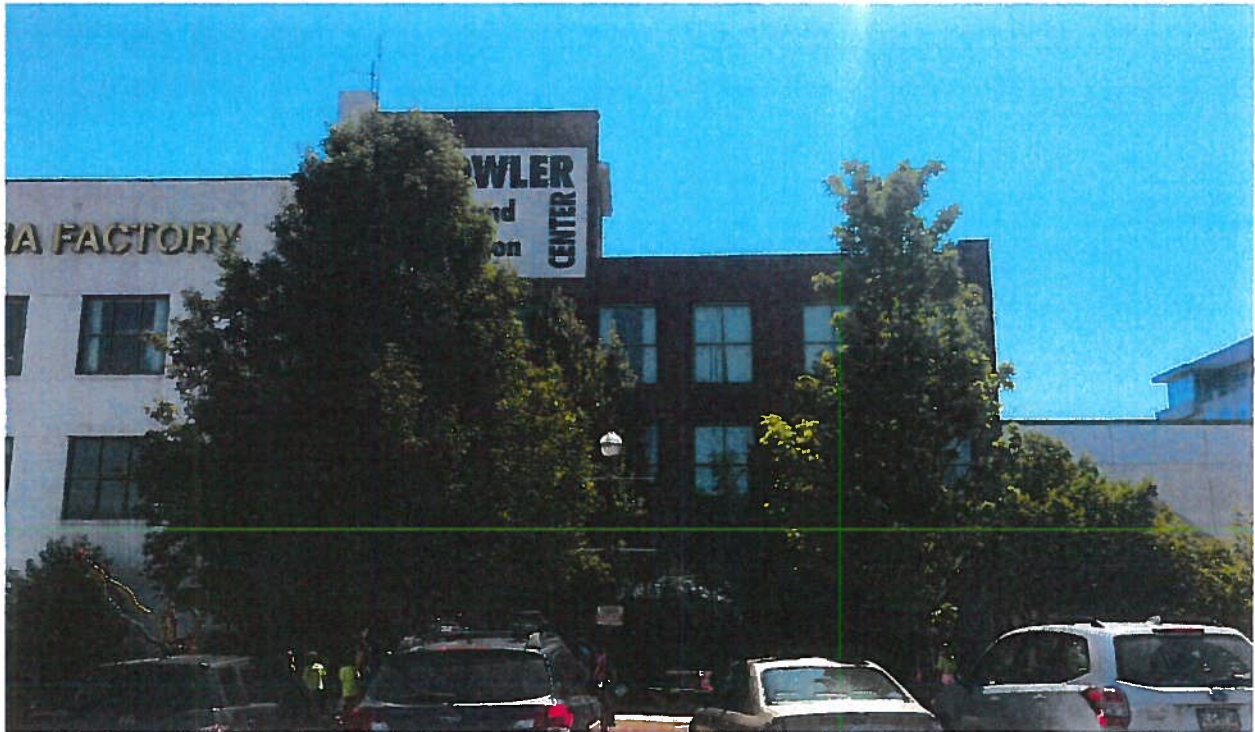
Above: Parking lot elevation (western exposure)

Much of the existing brick facades on the Eastern and Western sides require repointing, particularly at the top of the walls where water has probably leaked through compromised flashing beneath parapet cap stonework.

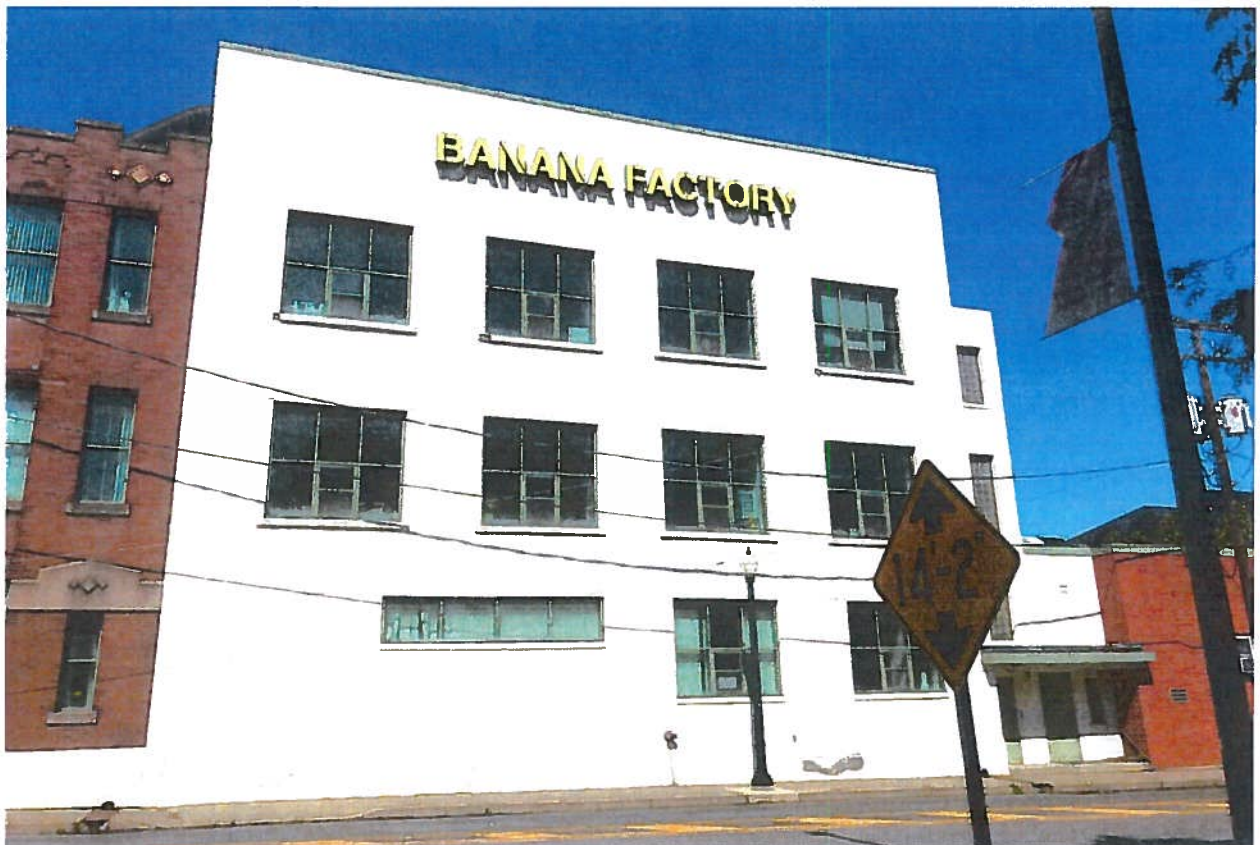
Above: Northampton Street elevation (eastern exposure)

built by the D. Theodoredis Wholesale Banana Company. This building is now altered with aluminum storefront windows and stucco finish and has lost much of its historic integrity. The building, however, is clearly associated with the Theodoredis business.

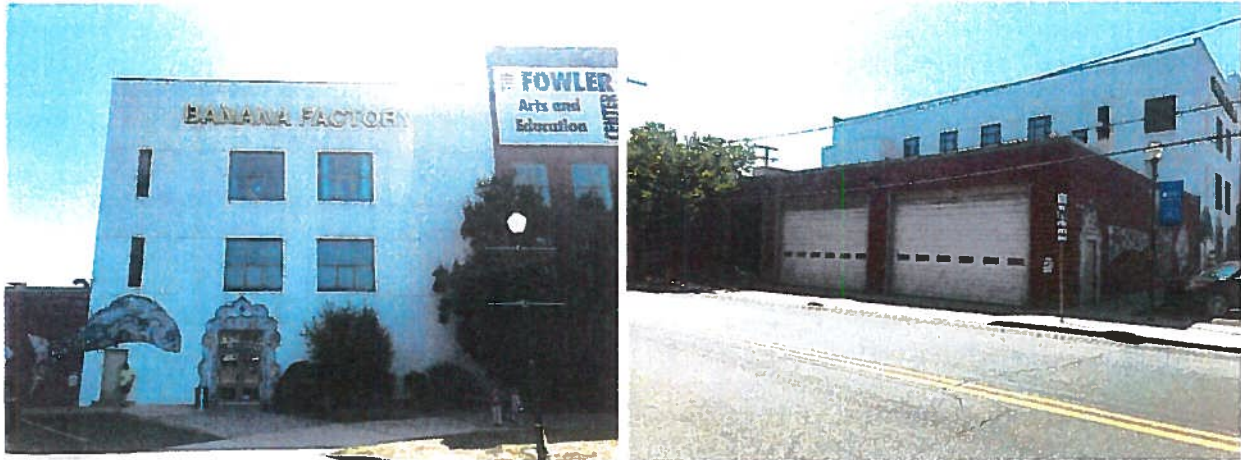
Left: Parking lot elevation (western exposure), Right: 2nd Street elevation (northern exposure)

Many cracks have telegraphed through the stucco cladding from the original masonry backup, indicating that the structural integrity of the masonry is in decline.

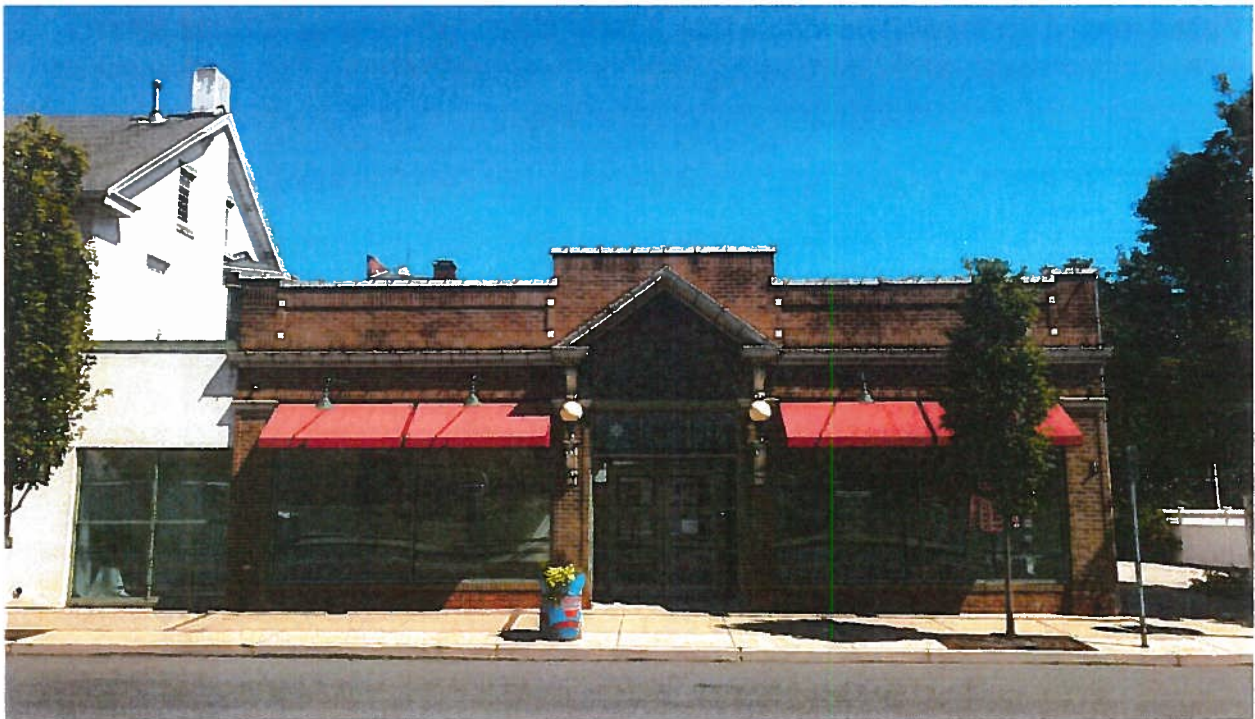
Above: 3rd Street elevation (southern exposure)

The former auto parts store building dates from c. 1920-1929 based on its style, detailing, and time period of major growth and building along Third St. The building is Classical Revival in style and includes terra cotta cornice, terra cotta entry gable with scroll brackets and lighting consoles, arched transom over entry doors with Classical Revival fanlight, large display windows, and parapet with terra cotta coping. The building retains historic integrity despite some alterations when the building was renovated for a gallery for the Banana Factory.

ArtsQuest's intent is to gently clean the existing masonry on the 3rd street façade using appropriate preservation methods, repoint the masonry where appropriate, selectively replace deteriorated wood trim as necessary, and paint the wood trim.

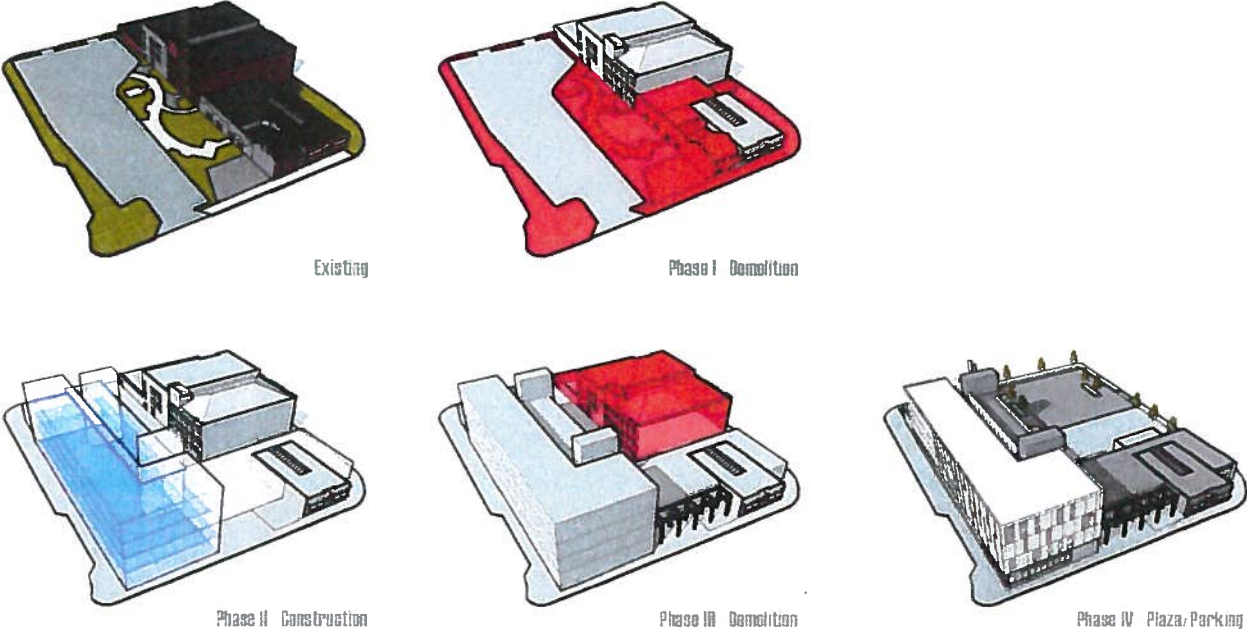
ArtsQuest South Bethlehem Phasing & Massing

Below: Phasing Diagram (early preliminary design)

The design of the new facility follows the function of the phasing but considers the wider urban context of the site in the massing of the proposed new building. The proposed design places a 4-story building volume along the western edge of the site – note that the city of Bethlehem has plans to construct a new street along this edge of the site and the proposed building is configured to present an appropriate façade (with windows). The western façade of the proposed building follows the angle of the western property line.

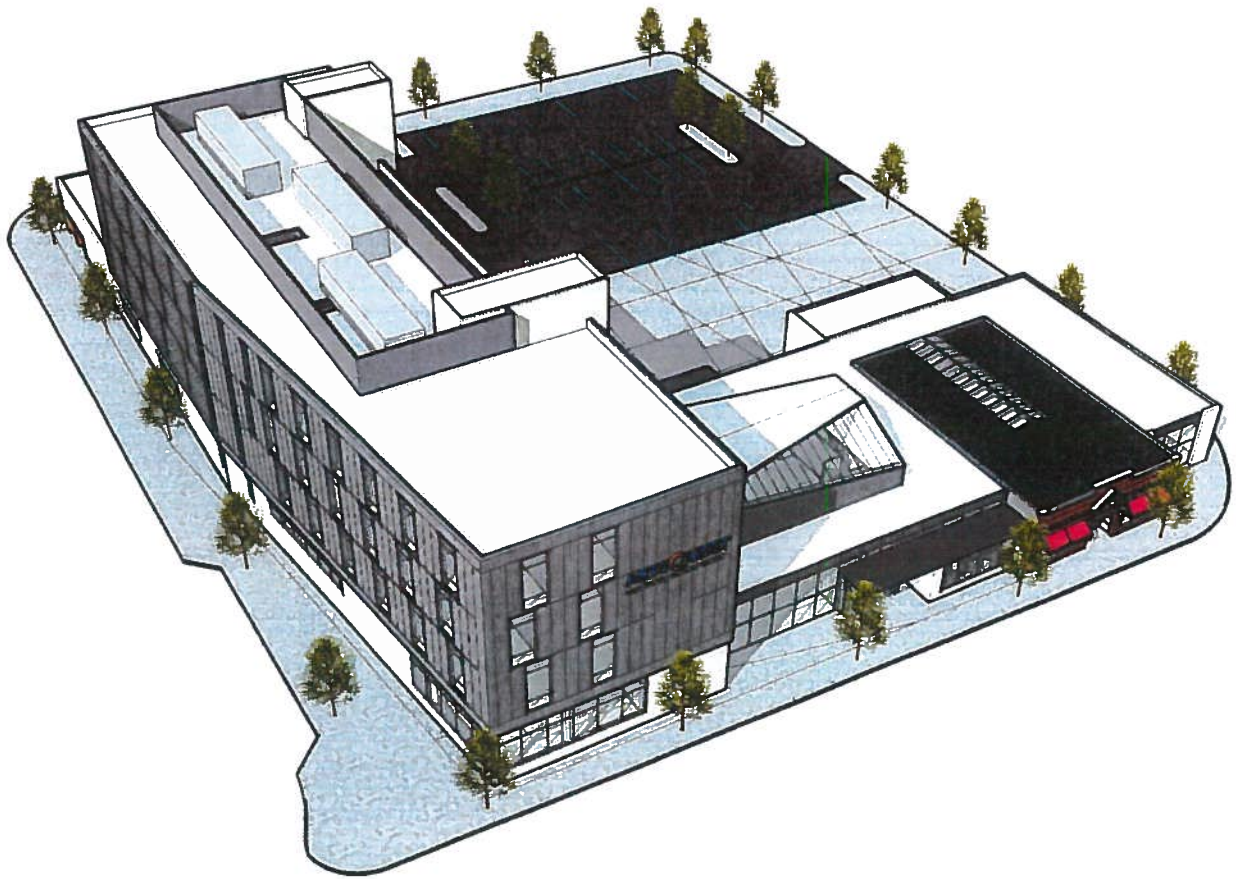
It is worth noting that several alternate massing options were explored and were not selected because they placed the 4-story volume along 3rd street which would overwhelm the scale of the street. The proposed design varies the height of the building along 3rd street between 4 stories and 1 story, while also preserving the single-story art gallery at the corner of 3rd and Northampton Streets.

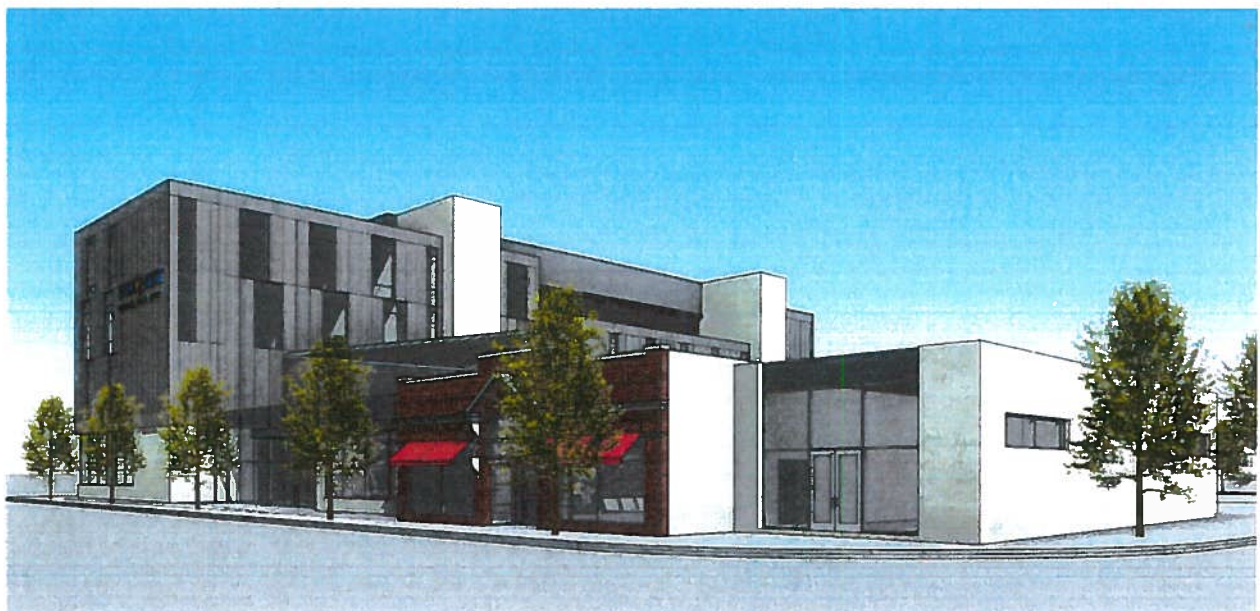
An arts plaza is proposed in the interior of the site, directly behind the single-story portion of the building and across the street from the steelworkers' memorial park. The programming for the arts plaza includes Arts festivals, outdoor art classes, and outdoor space for a proposed art-oriented pre-K program. Behind the arts plaza at the corner of 2nd and Northampton street is a proposed parking lot to provide parking for the building's resident artists and staff. Note that there is ample public parking in South Bethlehem to accommodate other users.

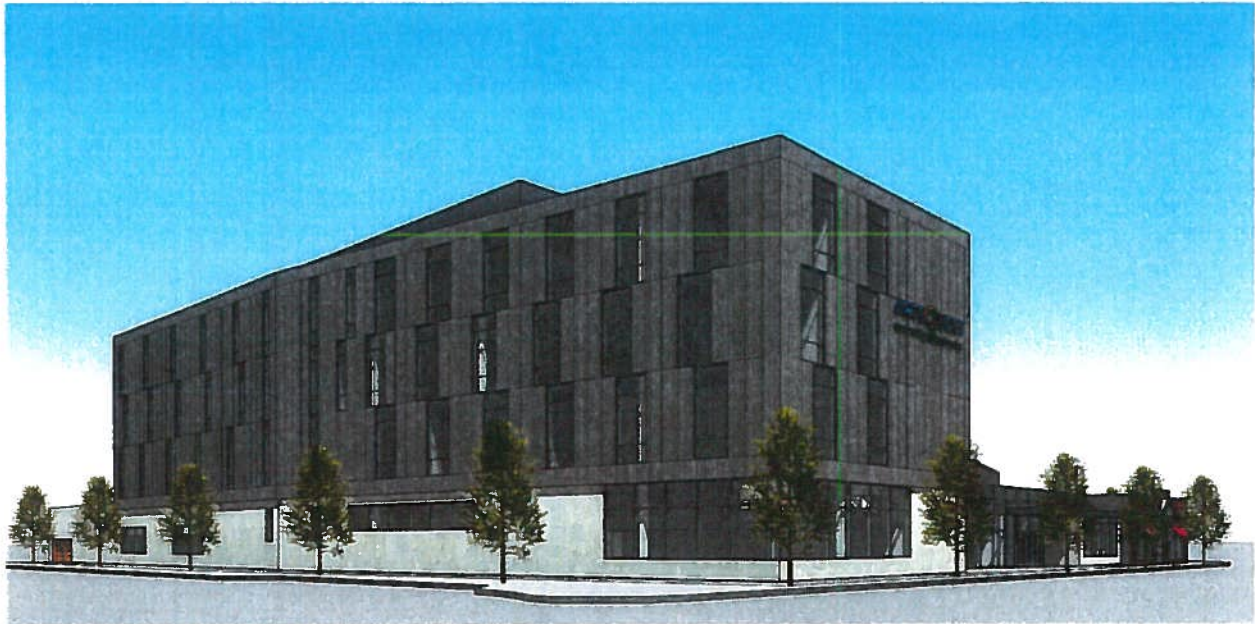
The proposed building separates the top three floors from the base through differentiation of materials; the base clad in precast concrete panels that relate in height to the existing Auto Parts store that will be preserved and integrated into the new facility. Multiple entrances along 3rd street, into the art galleries and into the lobby of the art center will create a sense of presence on the street and activate the streetscape for first Fridays and other community events by encouraging passersby to enter the building and to use the sidewalk to circulate between galleries.

The streetscape is further activated by large areas of glass along the 3rd street sidewalk that will allow passerby to view the art and activity within the community center. Furthermore, the lobby is glazed on both sides, facilitating views from the sidewalk through to the arts plaza behind the building.

Roof top equipment will be screened from view with a rooftop screen assembly that matches the metal panel cladding of the building.
