**APPLICATION FOR CERTIFICATE OF APPROPRIATENESS (COA)**

Building address 520 East 4th Street, Bethlehem, PA 18015

Re: Hispanic Center  
520 East Fourth Street  
City of Bethlehem, Northampton Co., PA

**RE: HOUSE SURVEY OF EXISTING CONDITIONS  
520 E 4TH ST, BETHLEHEM, PA 18015**

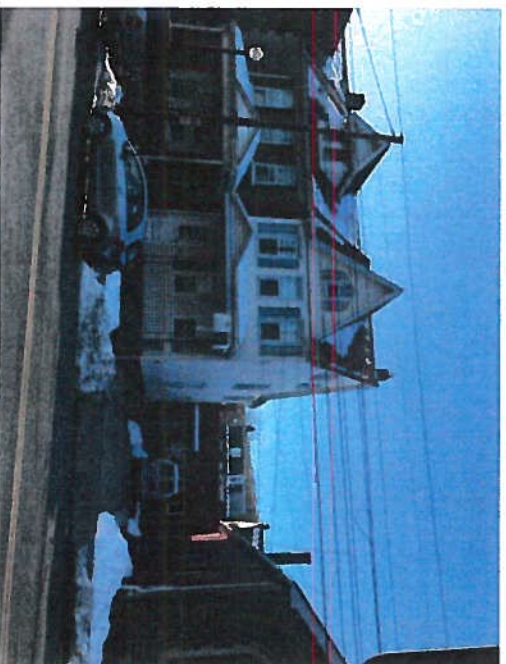
Photograph 1

Showing the Hispanic Center including stone structure  
to right side of picture, house to left side of picture and  
brick connecting structure between to the rear

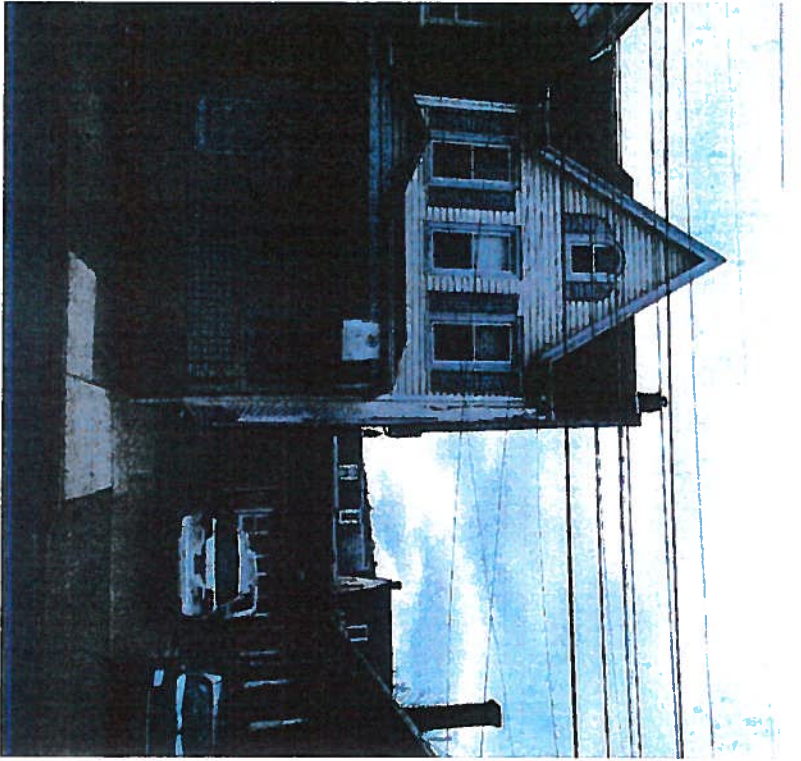
Photo 1

The house (approximately 17'x40') is a three-story wood framed structure with vinyl siding, a full basement, rubble stone foundation walls (See Photo 1). The 2x first, second floor and attic joists span the short direction (East to West) of the house. The main roof has a A frame running east to west in the middle with a dormer out the front (North) and a reverse A in the back (South) of the house.
